PHASE II ENVIRONMENTAL SITE ASSESSMENT

"BIEGELS BAR PROPERTY": 19TH CENTRAL AVENUE SOUTH, HARLOWTON, MT 59036

January 15, 2019

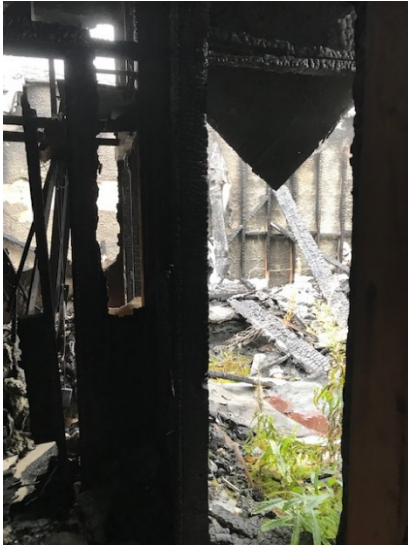
View of top floor from top of steps.

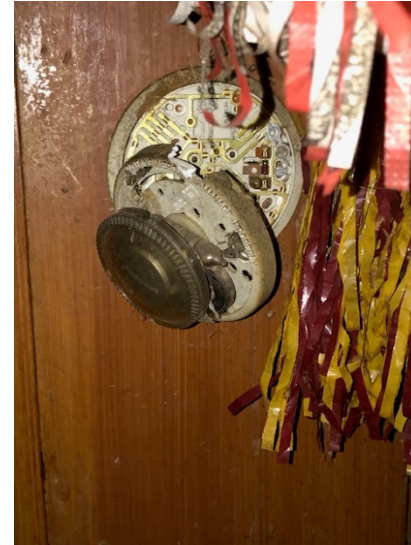
- No PCB-containing ballasts were identified. PCBs are not considered COCs.
- One thermostat switch was observed. The thermostat appears to contain a mercury component. Mercury is considered a COC.

Thermostat behind bar containing mercury.

- The observed mercury-containing thermostat switch should be properly removed, prior to relevant demolition activities, and properly disposed of.
- If PCB-containing equipment is encountered, although none were observed, they should be properly removed prior to relevant demolition activities, and properly disposed of.

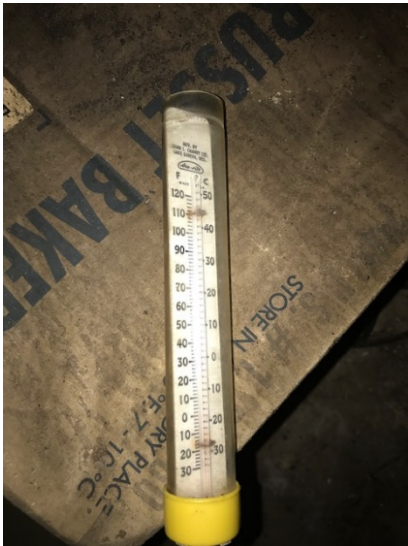
Newer thermostat that does not appear to contain mercury.

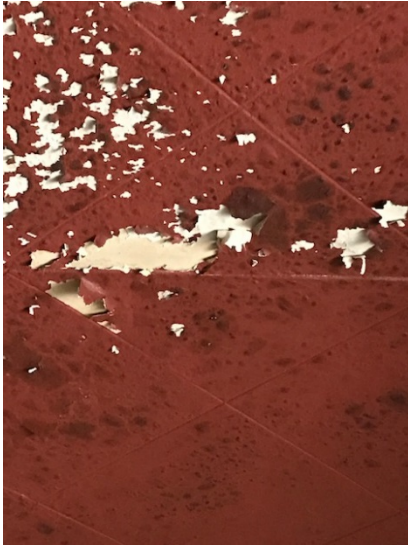
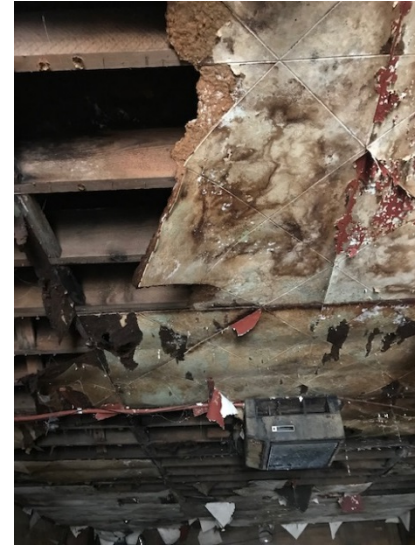
- Mold was observed on wood in the basement near the former coolers and the ceiling of the main floor. Mold is considered a COC.

Mold and water damage on ceiling of main level.

- As the presence of mold was noted, precautionary measures are recommended during remediation or demolition activities.

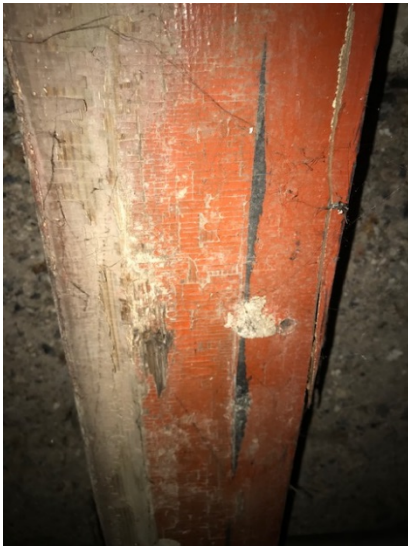
LBP on board in basement.

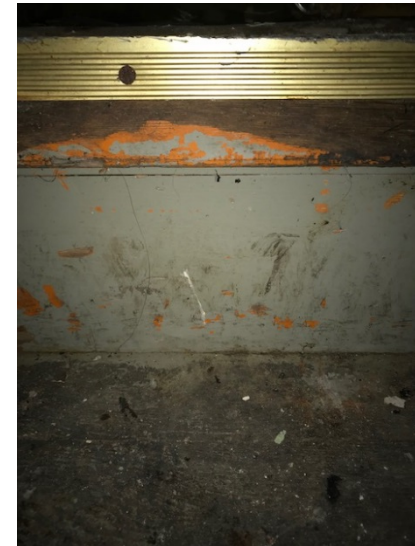
LBP on step riser (stairs to basement).

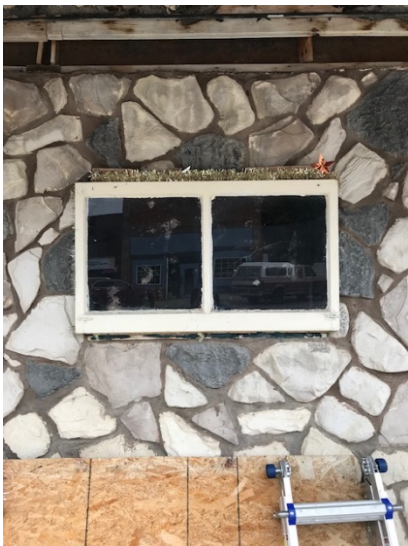
LBP around window frame.

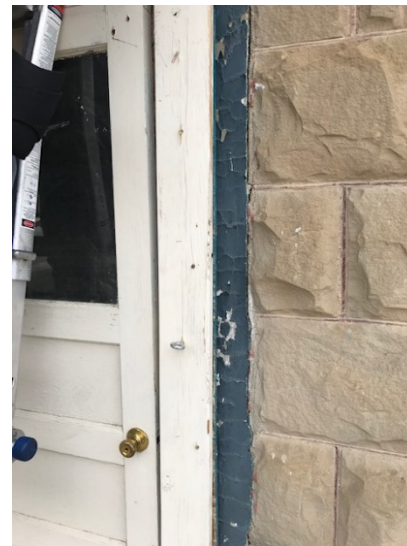
LBP around front door (the green and/or underlying paints).

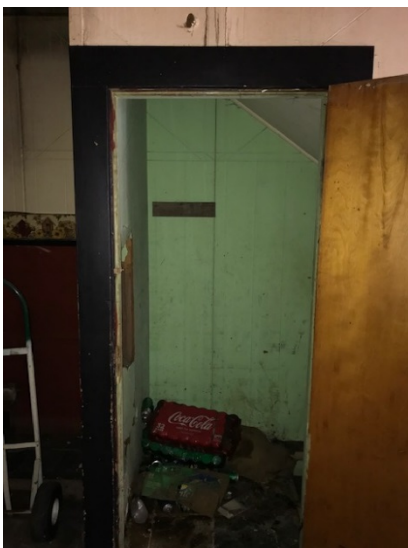
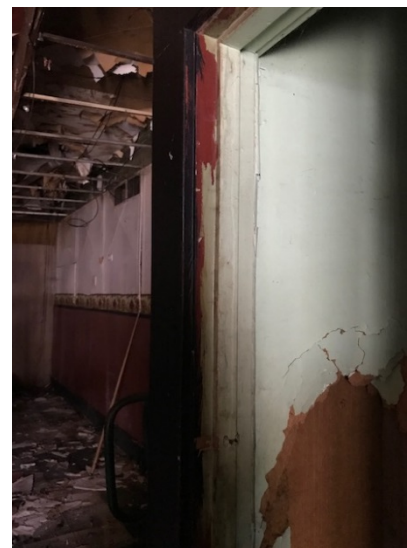
LBP around door to basement.
