**PHASE II ENVIRONMENTAL SITE ASSESSMENT
FOR
CROWLEY BUILDING
311 WEST MAIN STREET
LEWISTOWN, FERGUS COUNTY, MONTANA**

Date Prepared	September 2017
TDD No.	0003/1705-13
Document Control No.	W0487.1A.01404
Contract No.	EP-S8-13-01
U.S. EPA Work Assignment Manager	Greg Davis

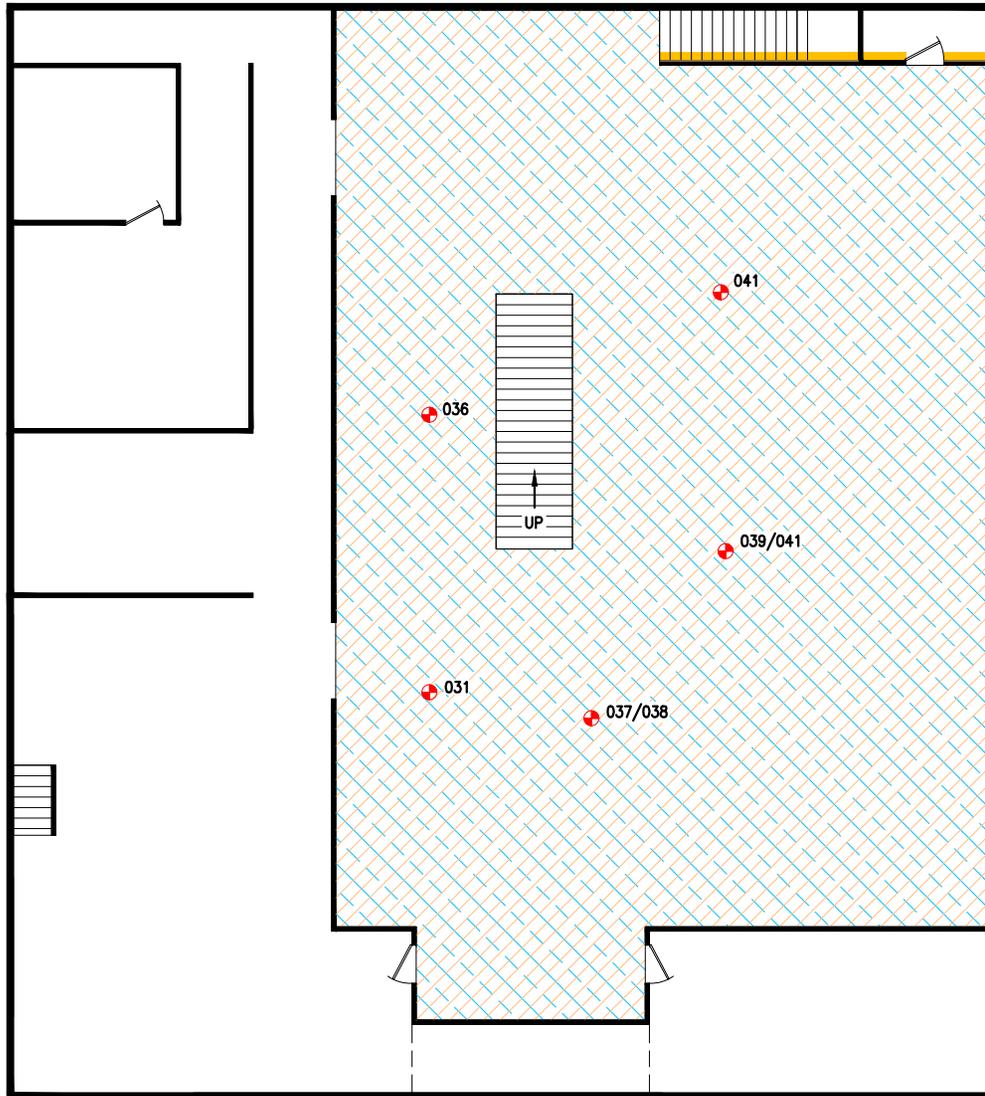
Figure
3

**ACM SAMPLE LOCATION AND EXTENT MAP
CROWLEY BUILDING – BASEMENT
LEWISTOWN, FERGUS COUNTY, MONTANA
HAZARDOUS BUILDING MATERIALS SURVEY**

- START recommends contracting an accredited asbestos remediation company to determine appropriate remedial actions to address the ACM at the Site during the cleanup phase of redevelopment (e.g., abatement, encapsulation, etc.). ACM remediation is recommended prior to any renovation or demolition activities at the Site.

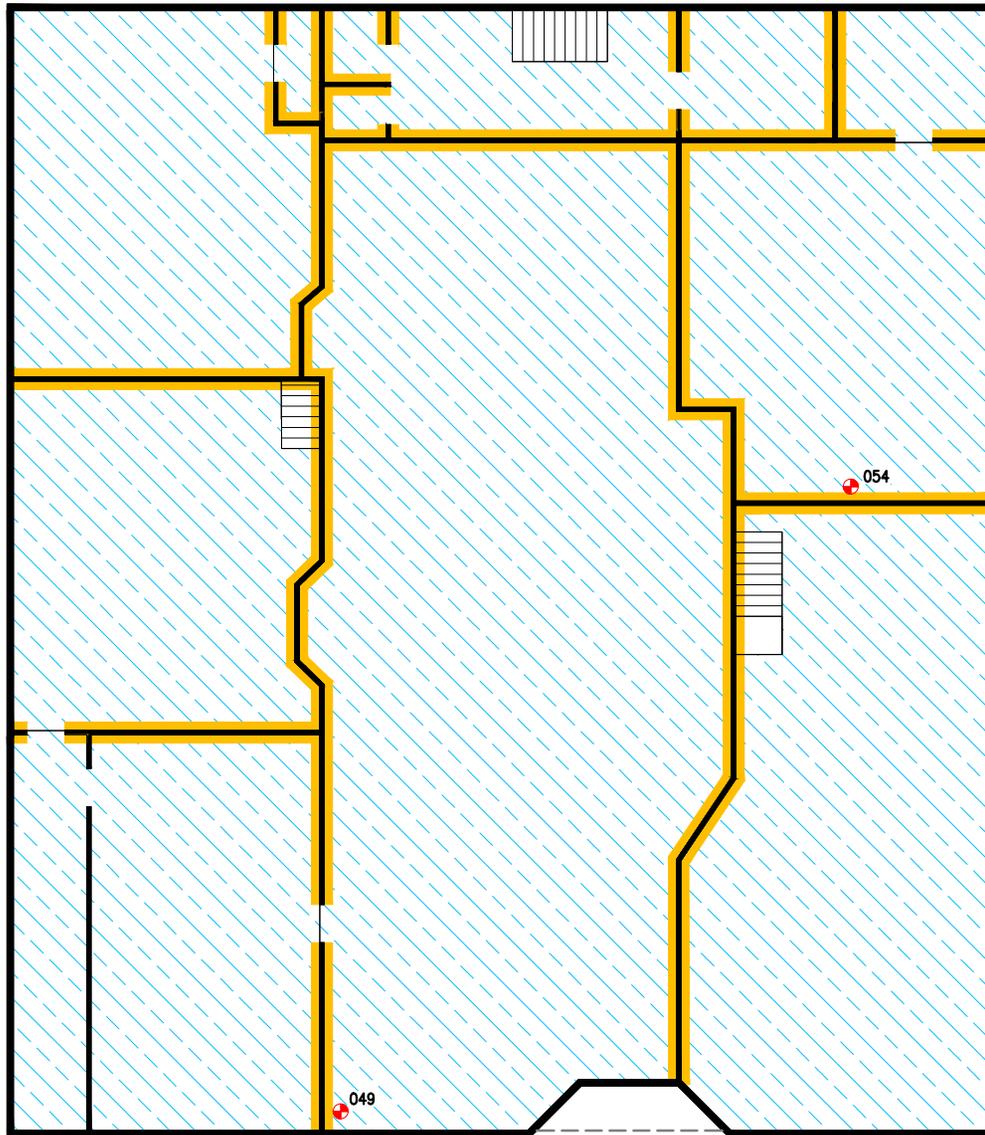
Figure
4

**ACM SAMPLE LOCATION AND EXTENT MAP
CROWLEY BUILDING – FIRST FLOOR
LEWISTOWN, FERGUS COUNTY, MONTANA
HAZARDOUS BUILDING MATERIALS SURVEY**

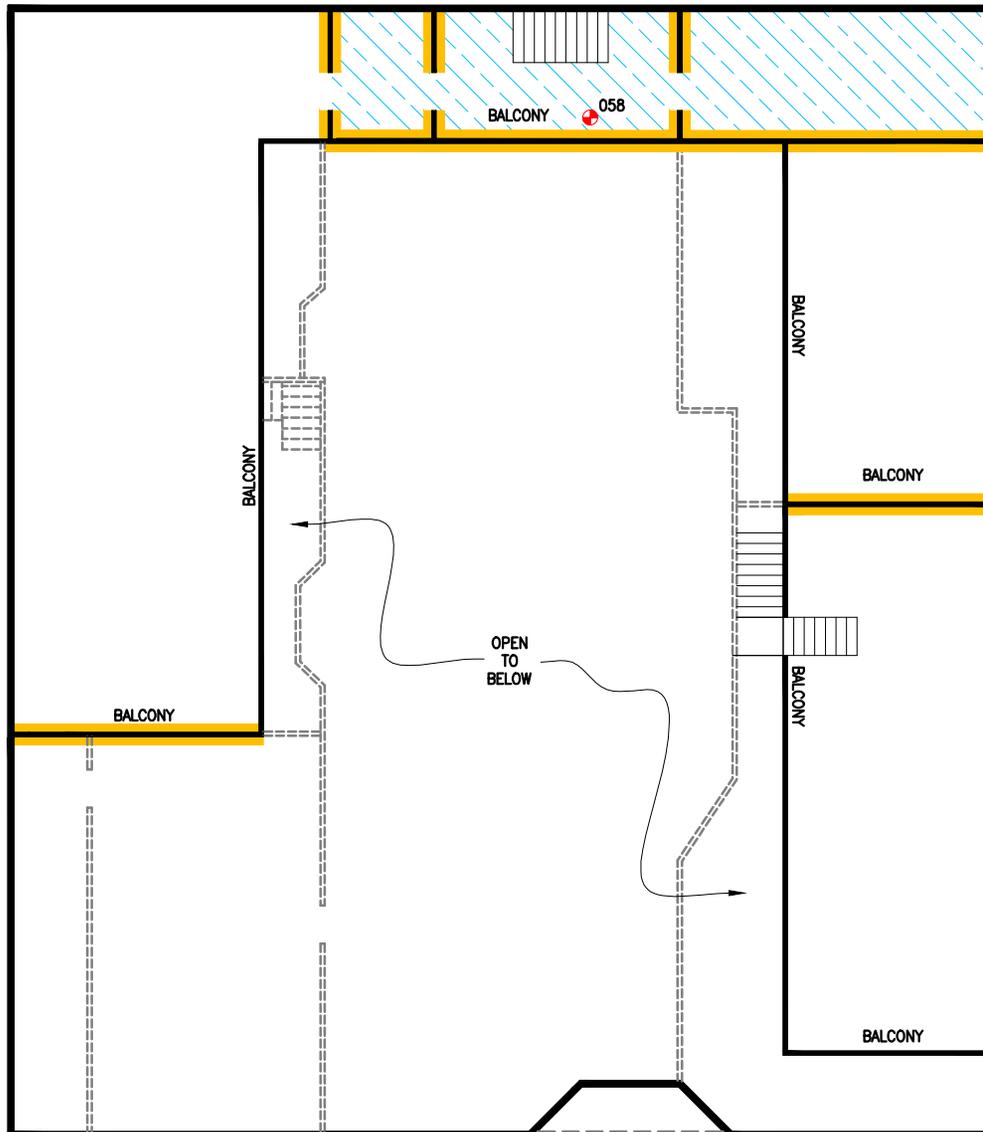
Figure
5

**ACM SAMPLE LOCATION AND EXTENT MAP
CROWLEY BUILDING – FIRST FLOOR BALCONY
LEWISTOWN, FERGUS COUNTY, MONTANA
HAZARDOUS BUILDING MATERIALS SURVEY**

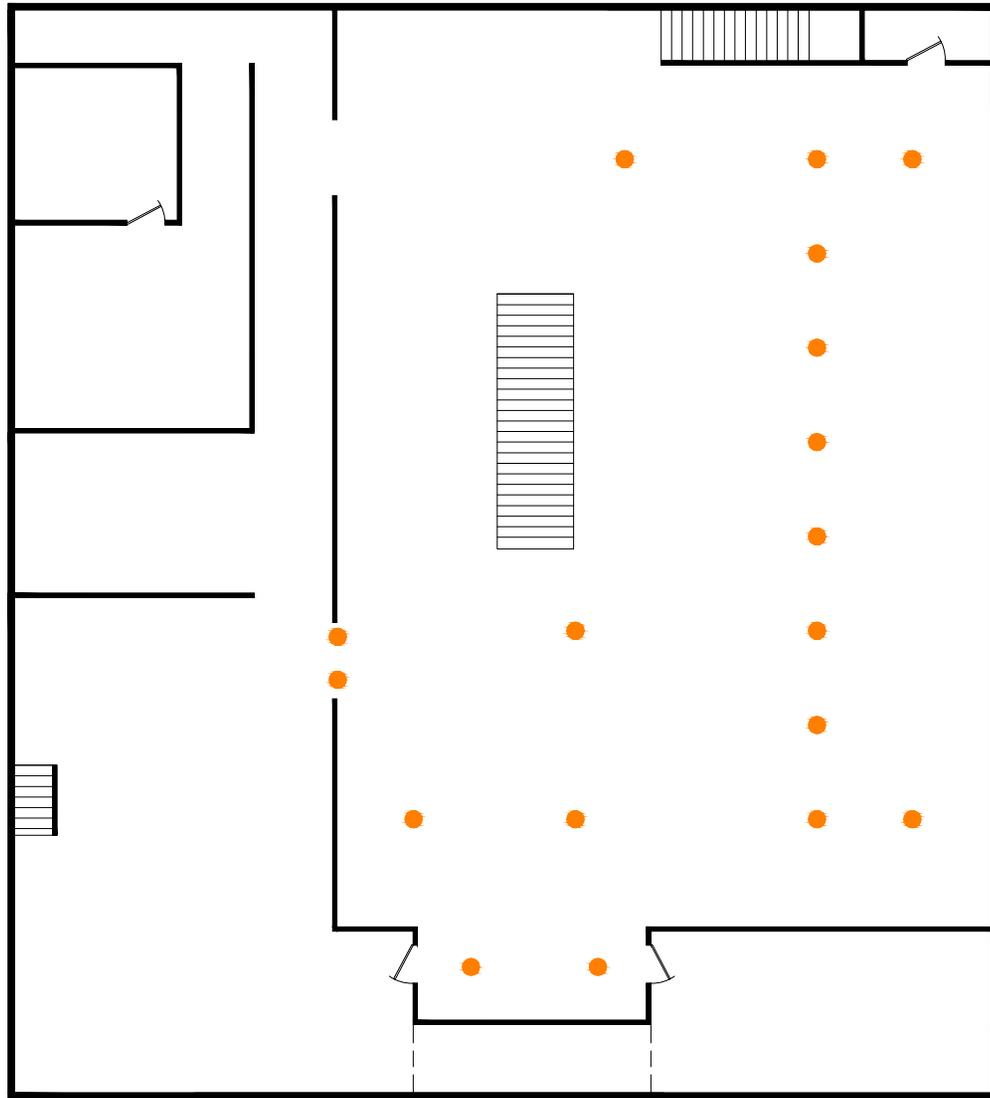
Figure
6

**LBP LOCATION AND EXTENT MAP
CROWLEY BUILDING – BASEMENT
LEWISTOWN, FERGUS COUNTY, MONTANA
HAZARDOUS BUILDING MATERIALS SURVEY**

- START recommends contracting an accredited lead remediation company to determine appropriate remedial actions to address the LBP at the Site during the cleanup phase of redevelopment and to assess disposal requirements for LBP at the Site (e.g., encapsulation, chemical stripping, removal, etc.). Dust control methods should be implemented for the debris. All work performed should be done so by an EPA Lead-Safe certified firm. If LBP construction materials are to be removed, it is recommended that the construction debris disposal facility be contacted to determine if Toxicity Characteristic Leaching Procedure (TCLP) samples will be required.

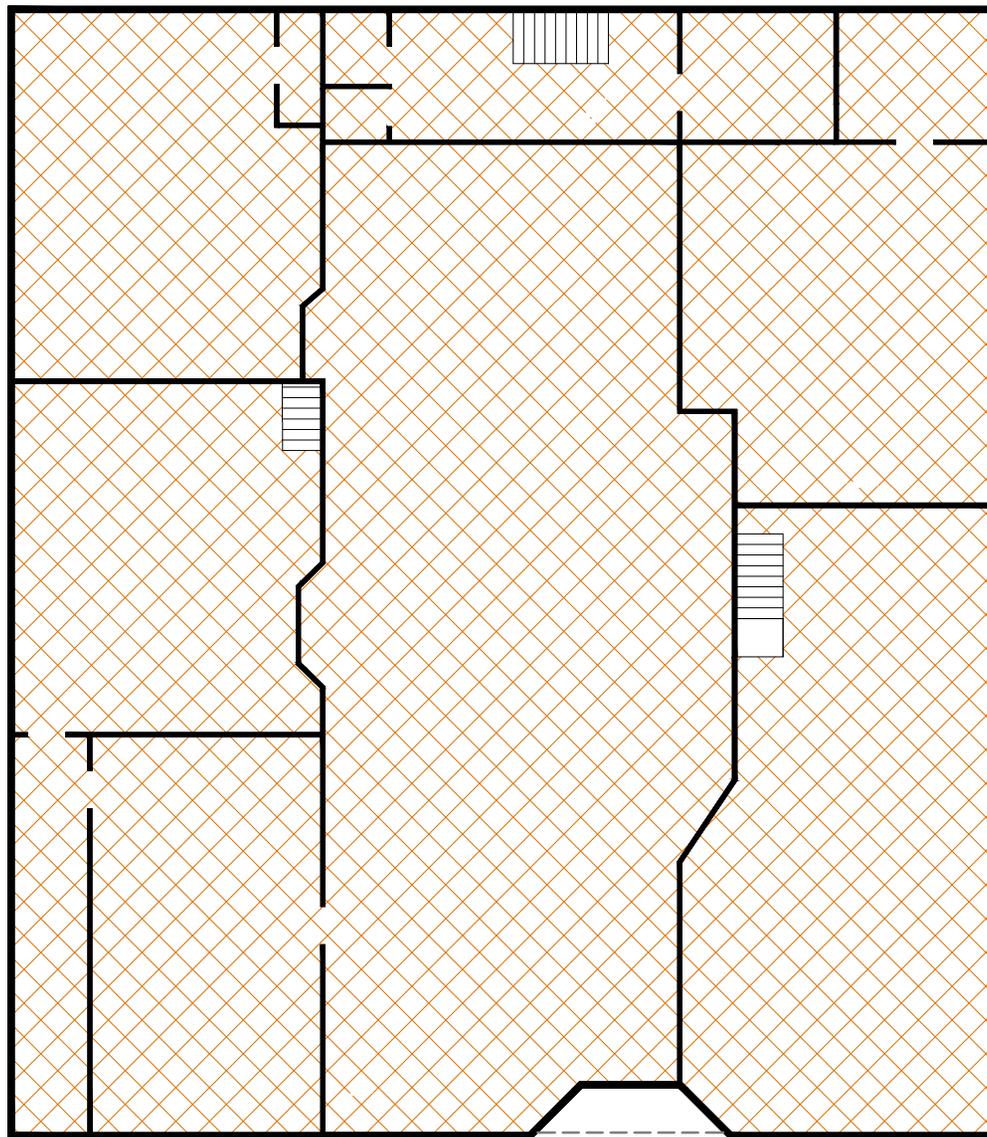
Figure
7

**LBP LOCATION AND EXTENT MAP
CROWLEY BUILDING - FIRST FLOOR
LEWISTOWN, FERGUS COUNTY, MONTANA
HAZARDOUS BUILDING MATERIALS SURVEY**

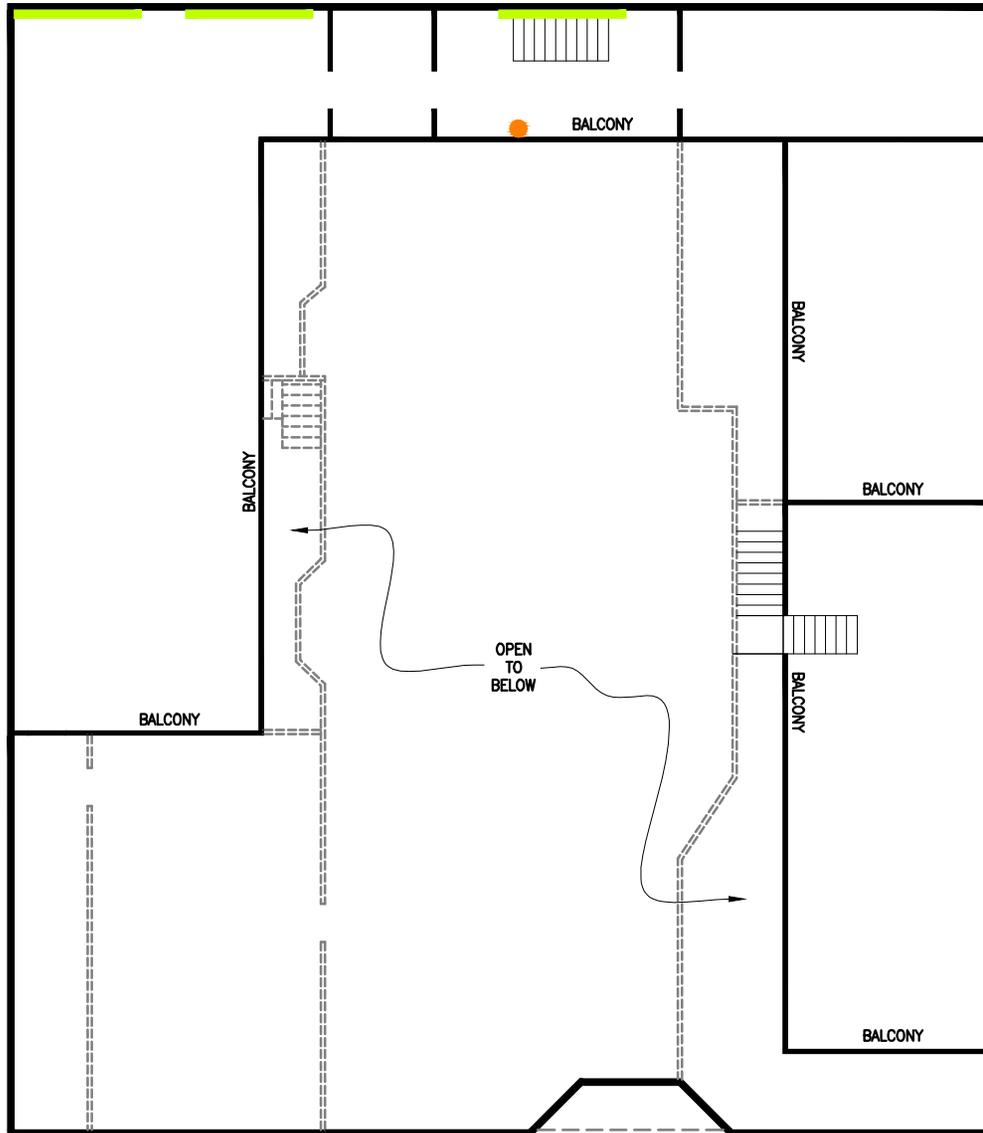
Figure
8

**LBP LOCATION AND EXTENT MAP
CROWLEY BUILDING – FIRST FLOOR BALCONY
LEWISTOWN, FERGUS COUNTY, MONTANA
HAZARDOUS BUILDING MATERIALS SURVEY**

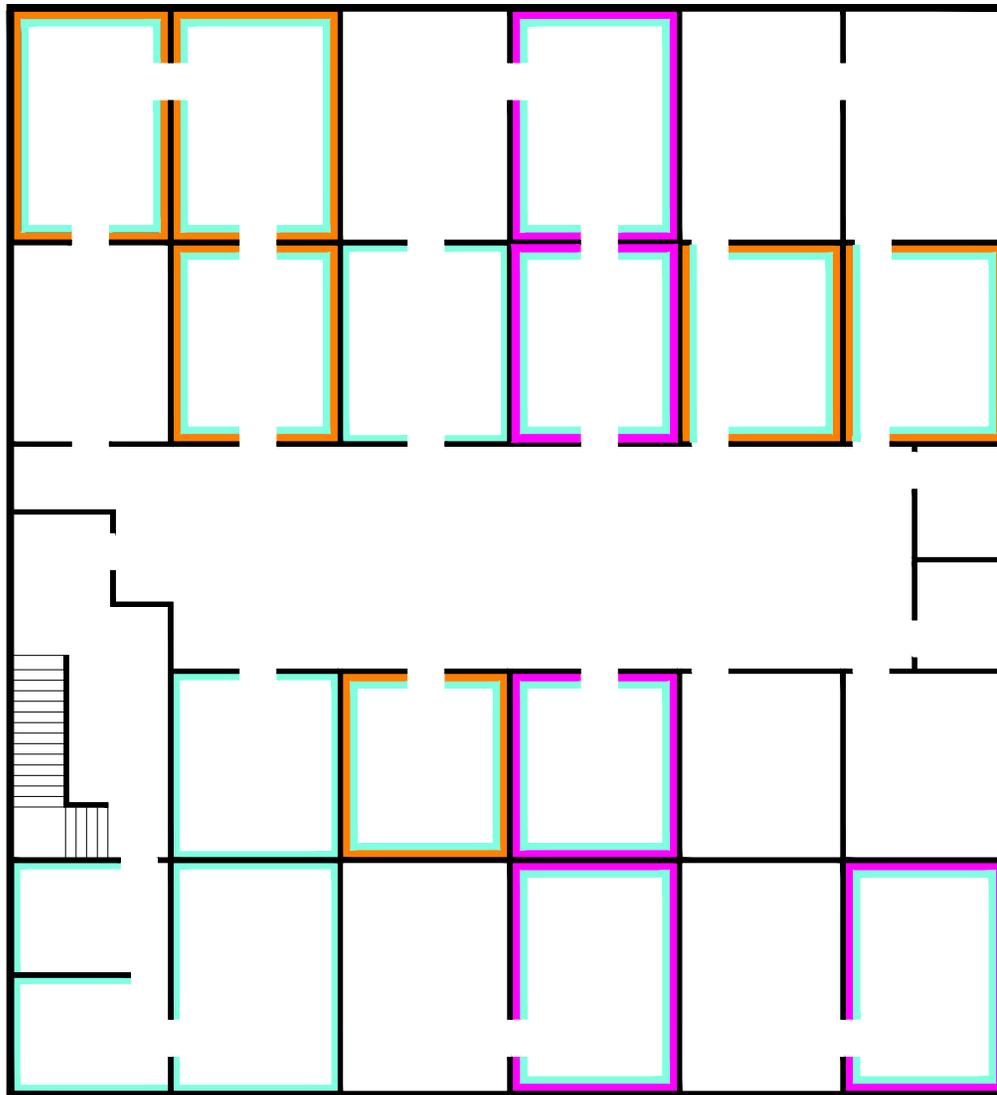
Figure
9

**LBP LOCATION AND EXTENT MAP
CROWLEY BUILDING – SECOND FLOOR
LEWISTOWN, FERGUS COUNTY, MONTANA
HAZARDOUS BUILDING MATERIALS SURVEY**

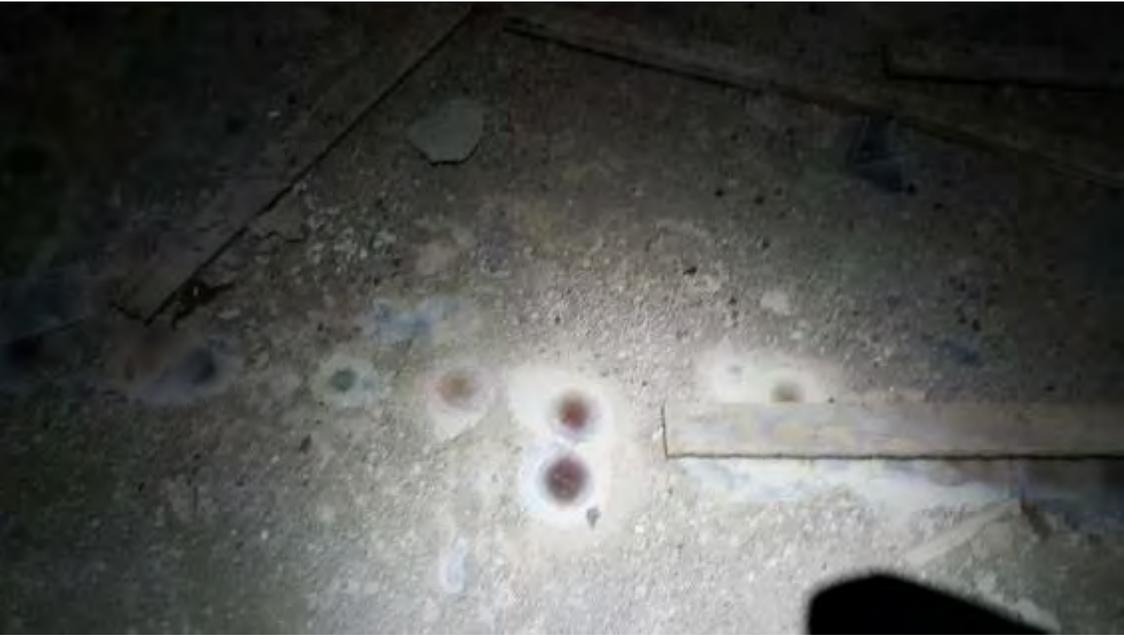
Photo No. 1	Date: 07/10/2017

- Two mercury switches were observed in the basement boiler room and seven thermostats were found on the first floor with mercury switches.
- Small spots of potential mold and areas with mildew staining were observed in the basement, however no large areas were found.

Photo Coordinates		
Lat	47.065278	
Long	-109.426389	
Direction Photo Taken: Down		
Description: Potential Mold in basement of building.

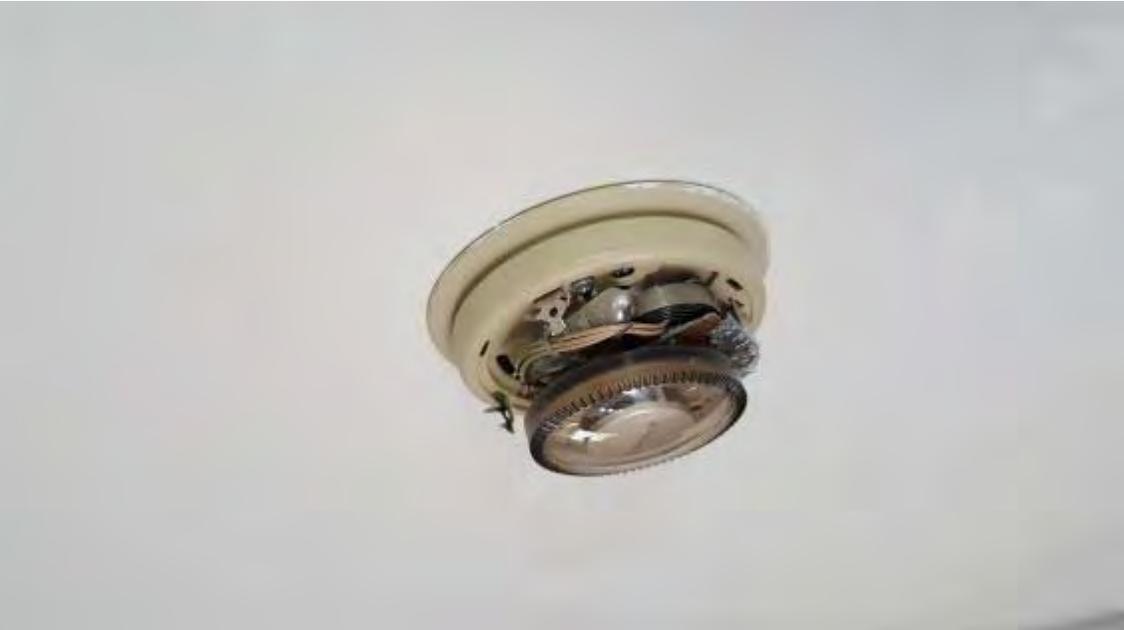
Photo No. 2	Date: 07/10/2017

Photo Coordinates		
Lat	47.065	
Long	-109.426389	
Direction Photo Taken: Southeast		
Description: Mercury containing thermostat on main floor.

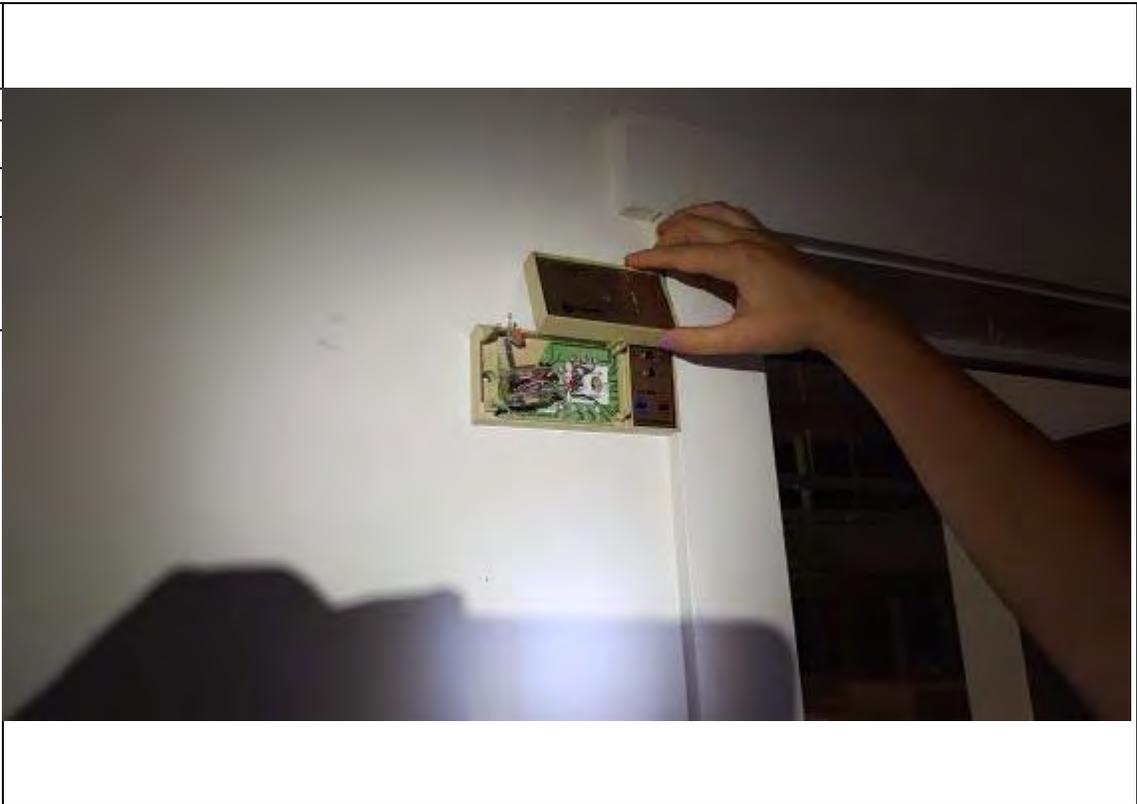
Description:
Mercury containing thermostat on main floor,

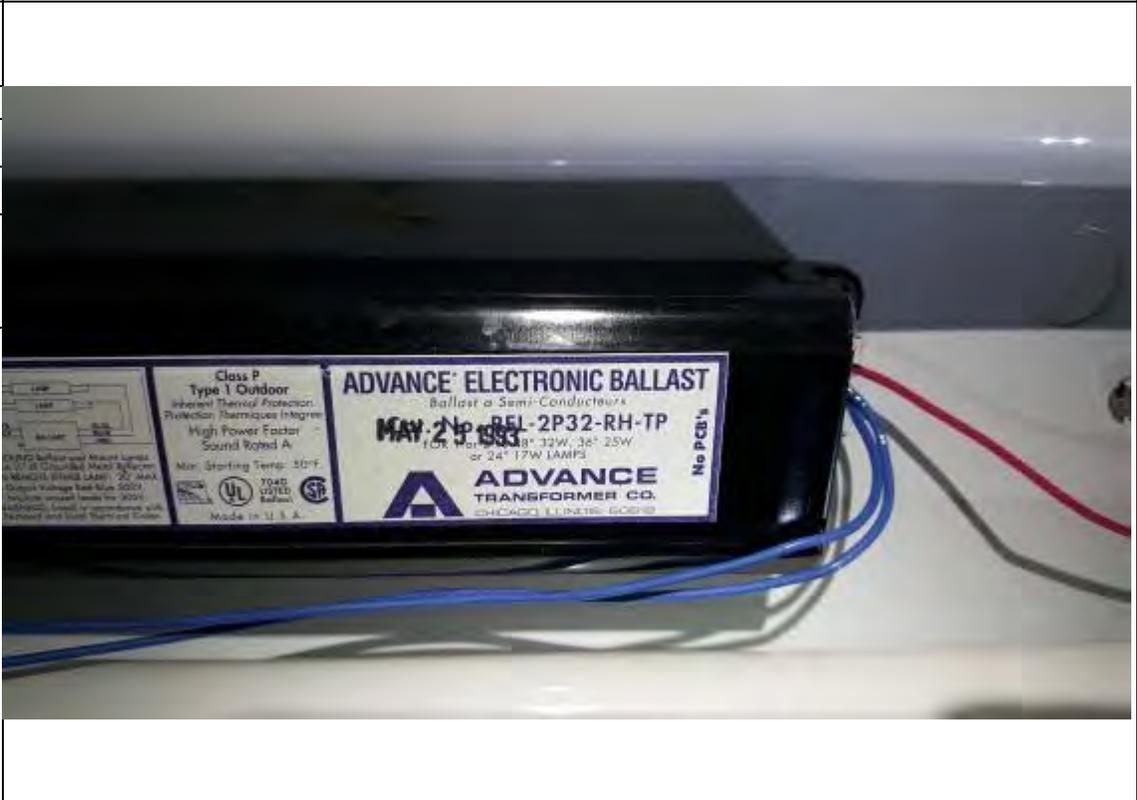
Photo No.
4

Description:
Lighting ballast with “no-PCB” sticker.

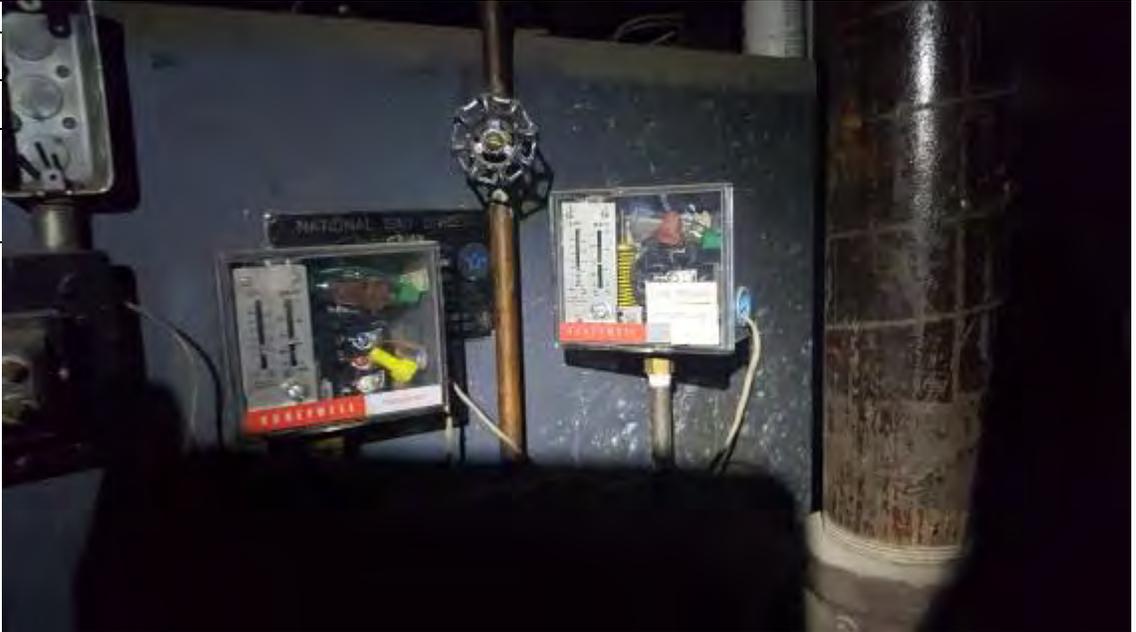
Photo No. 5	Date: 07/10/2017
Photo Coordinates	
Lat	47.065
Long	-109.426111
Direction Photo Taken: West	
Description: Mercury switches on boiler in basement boiler room.

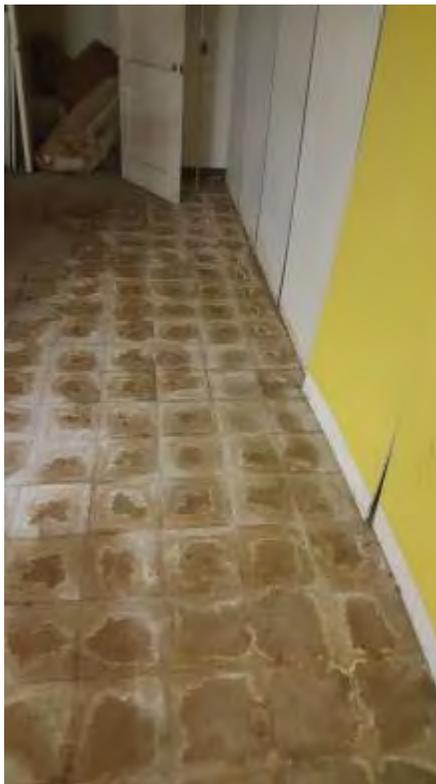
Photo No. 6	Date: 07/10/2017
Photo Coordinates	
Lat	47.065
Long	-109.426111
Direction Photo Taken: Southwest	
Description: Water damage on floor in basement. Note ACM tile.

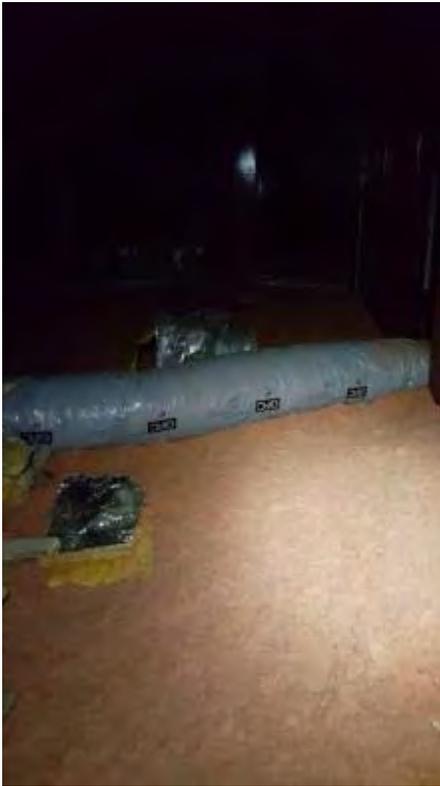
Photo No. 9	Date: 07/11/2017
Photo Coordinates	
Lat	--
Long	--
Direction Photo Taken: Southwest	
Description: Second floor with pass-through openings to third floor. Note HVAC run across floor, pink insulation non-ACM.

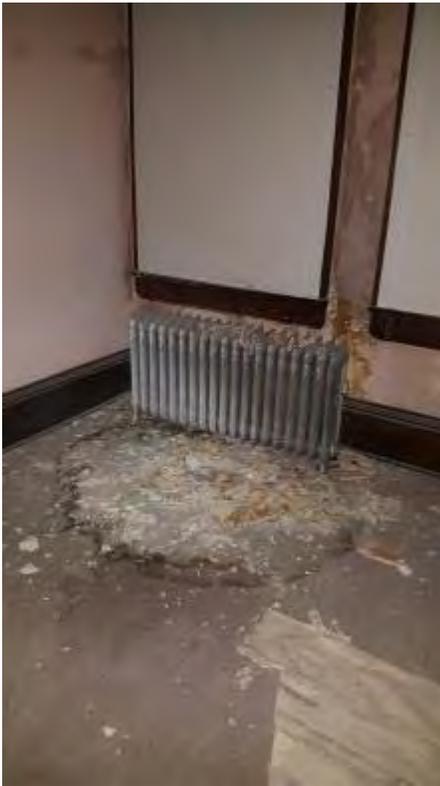
Photo No. 10	Date: 07/11/2017
Photo Coordinates	
Lat	--
Long	--
Direction Photo Taken: East	
Description: Water damage and deteriorating ceiling on third floor.
