**RE: Former Farmers Union, Final Hazardous Material Survey Report, Roundup, Montana, Task Order 09**

Snowy Mountain Development Corporation (SMDC) contracted Weston Solutions, Inc. (WESTON) to conduct a Hazardous Material Survey (HMS) at Former Farmers Union located at 101 2<sup>nd</sup> Street East, Roundup, Musselshell County, Montana (Site) (**Figure 1**). The legal description for the property is: Roundup Original Townsite, Section 13, Township 08 N, Range 25 E, Block 022, Lot 005, E 84 FT of Lts 5 & 6 BLK 22 RND ORIG. The Site is located at the corner of 2<sup>nd</sup> Street East and 1<sup>st</sup> Avenue East. The Site consist of a 1,648 square foot two-story wood building with a basement that was constructed in 1935. The building was most recently used as a foodbank and is currently unoccupied.

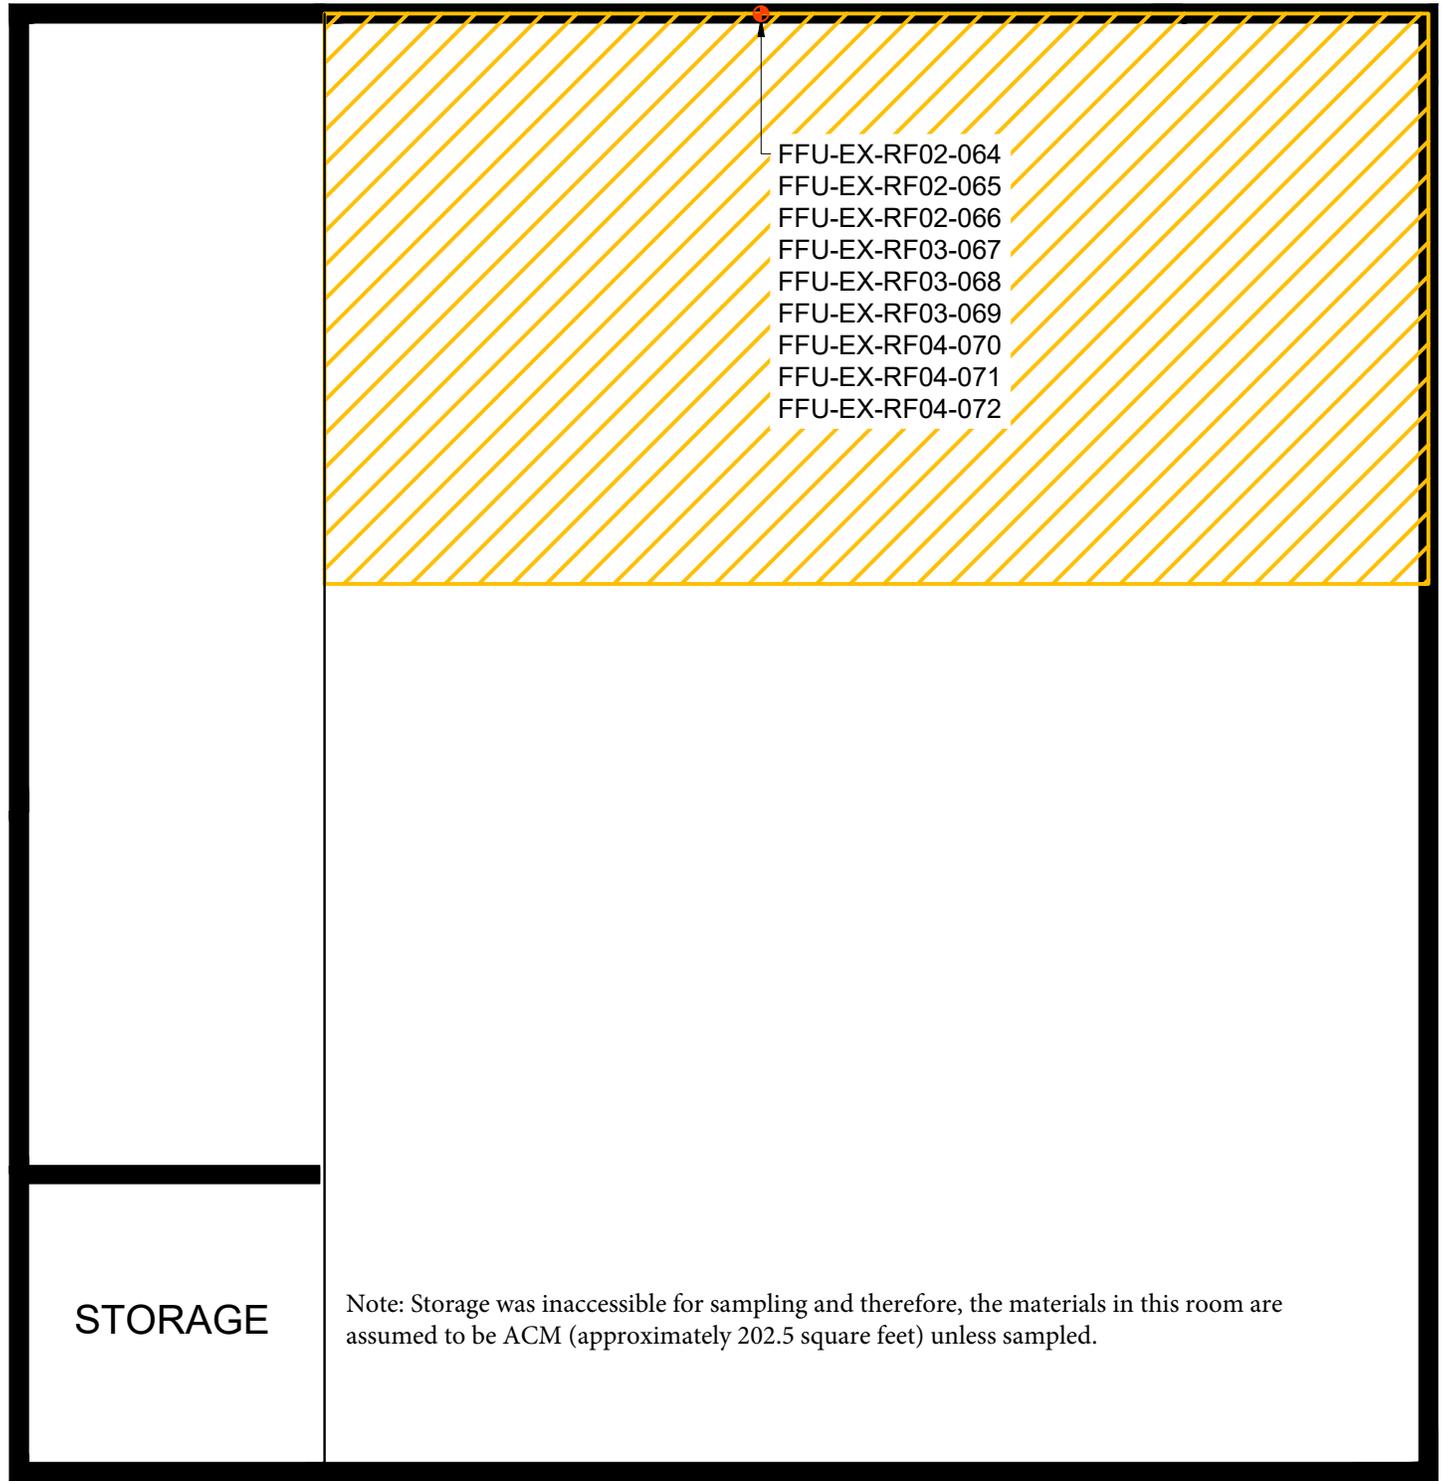
**FIGURE 2 - ASBESTOS CONTAINING MATERIAL**  
**FORMER FARMERS'S UNION**  
**101 2nd STREET EAST**  
**ROUNDUP, MT**

Based on the results of the surveys and sampling conducted at the Site, ACM is present on approximately 480 sq. ft. of roofing material and assumed to be present on approximately 202.5 sq. ft. of the Storage room. LBP is present on a total of approximately 299 square feet of window and door trim, walls, and ceilings of the building, and assumed to be present on approximately 202.5 sq. ft. of the Storage room. One potential PCB-containing light fixture was observed on the second floor and a single mercury thermostat was identified on the first floor of the building.

- Based on the ACM identified at the Site and planned demolition of the building, WESTON recommends contracting an accredited asbestos remediation company to assess hazard risk and determine appropriate remedial actions to address ACM at the Site prior to demolition (e.g., abatement, encapsulation, etc.). ACM remediation is recommended prior to demolition activities at the Site. Prior to any demolition, a proper plan for mitigation and/or disposal of ACM should be developed, and any work conducted should be performed by a company certified to handle ACM. In addition, for the inaccessible area, building materials that are not wood, metal, or glass should be disposed as ACM unless additional sampling occurs prior to demolition.

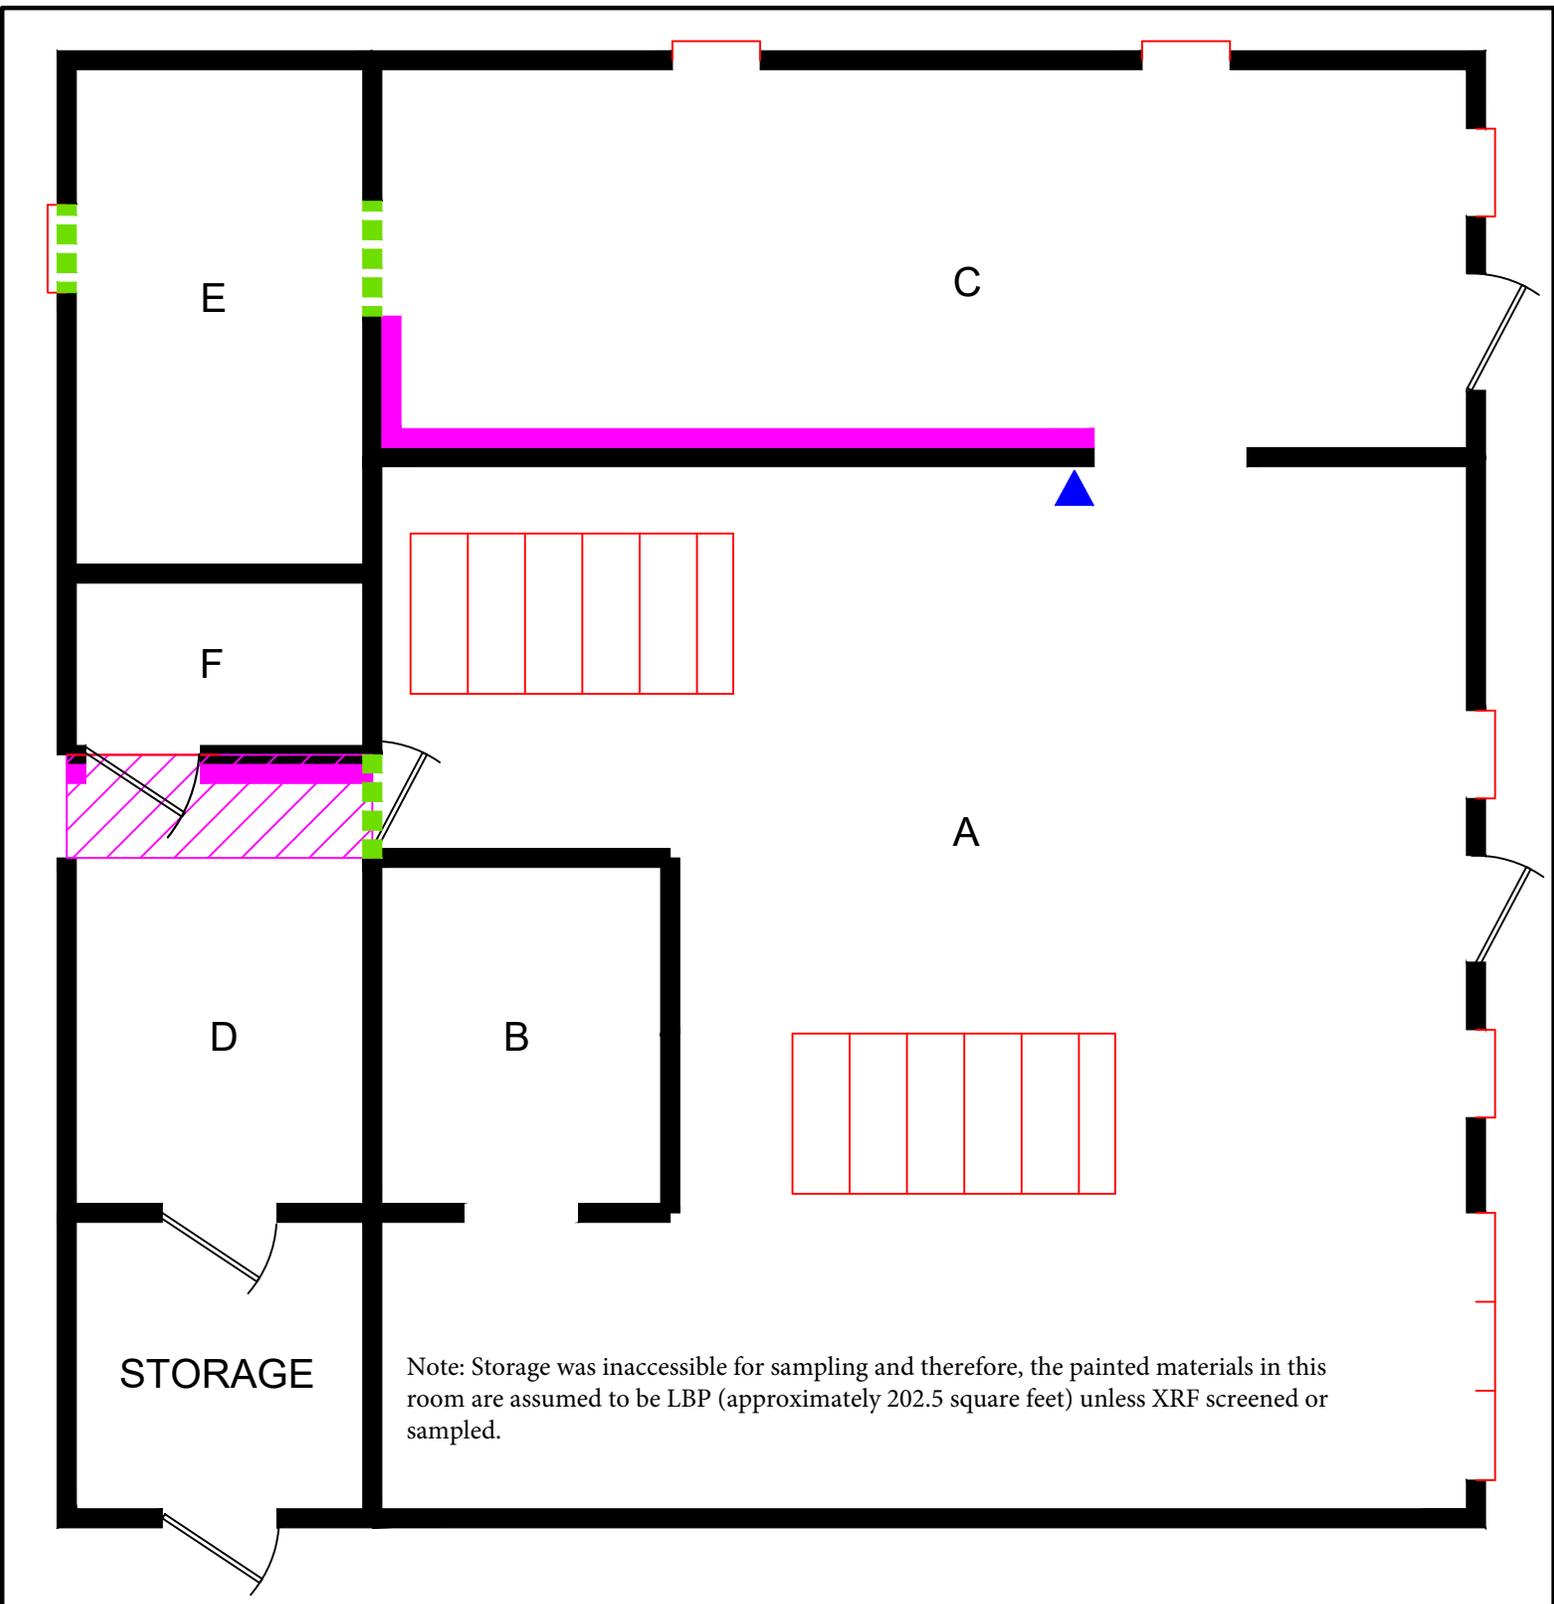
**FIGURE 3 - LEAD BASED PAINT  
 FORMER FARMERS'S UNION  
 101 2nd STREET EAST  
 ROUNDUP, MT**

Based on the XRF results, elevated lead concentrations are present on interior walls and door frames, and exterior window frames, walls, door frames, and ceilings. A complete list of XRF readings is presented in **Table 2**. The location and approximate extent of LBP identified is presented on **Figure 3**.

- WESTON recommends contracting an accredited lead remediation company to assess hazard risk and determine appropriate remedial actions to address LBP at the Site prior to demolition (e.g., encapsulation, chemical striping, removal, etc.). LBP regulations applicable to remediation project design and abatement activities such as EPA's RRP Rule and HUD Guidelines for the Evaluation and Control of Lead-Based Paint Hazards in Housing (2012 edition) (HUD, 2012) should be followed. If construction materials are to be removed, it is recommended that the construction debris disposal facility be contacted to determine if TCLP samples will be required. In addition, for the inaccessible area, painted materials present within the room are assumed to be LBP unless additional sampling occurs prior to demolition.

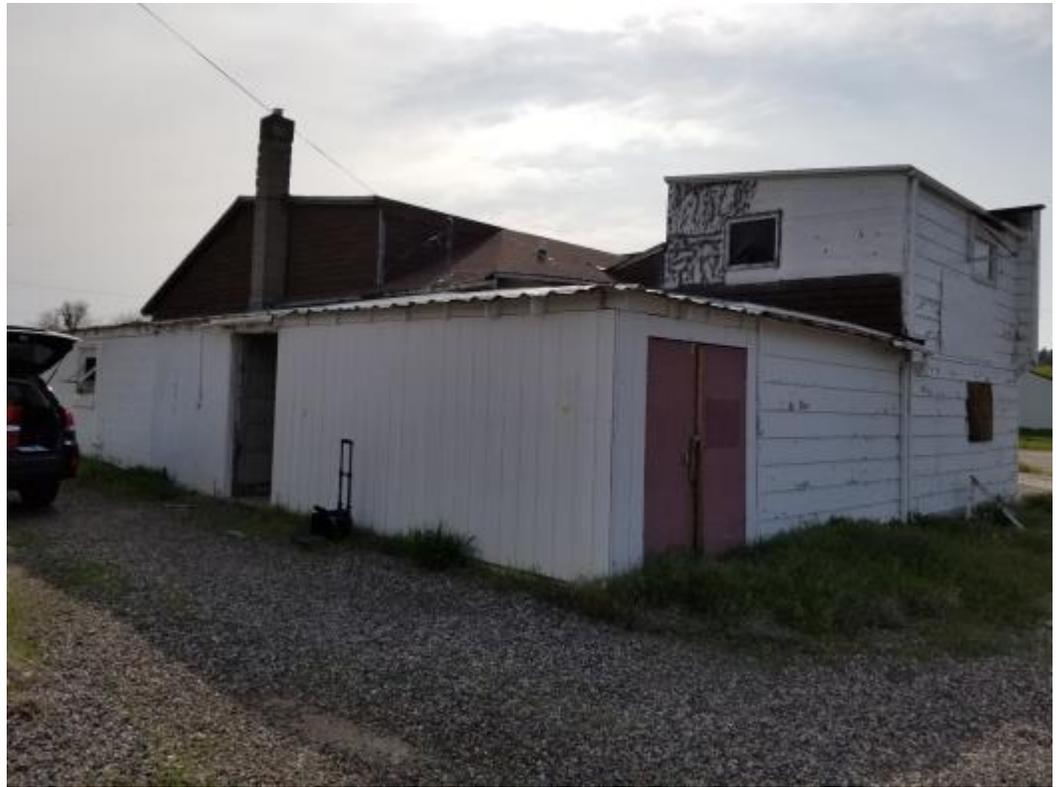
<b>Photo No.</b> <b>1</b>	<b>Date:</b> 06/20/2019
------------------------------	----------------------------

The rear and southwest side of the building. The roofing material shown is different from the other side of the building and tested negative for asbestos.

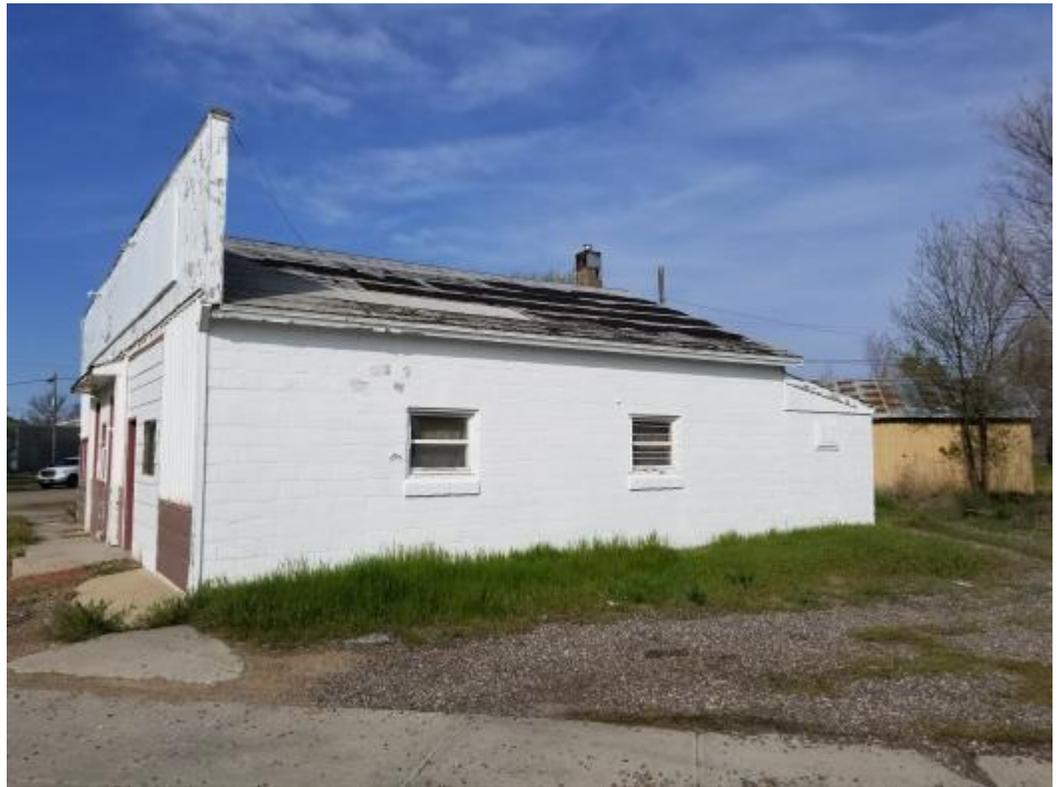
<b>Photo No.</b> <b>2</b>	<b>Date:</b> 06/20/2019
------------------------------	----------------------------

The front and northeast side of the building. The roofing material shown tested positive for asbestos.

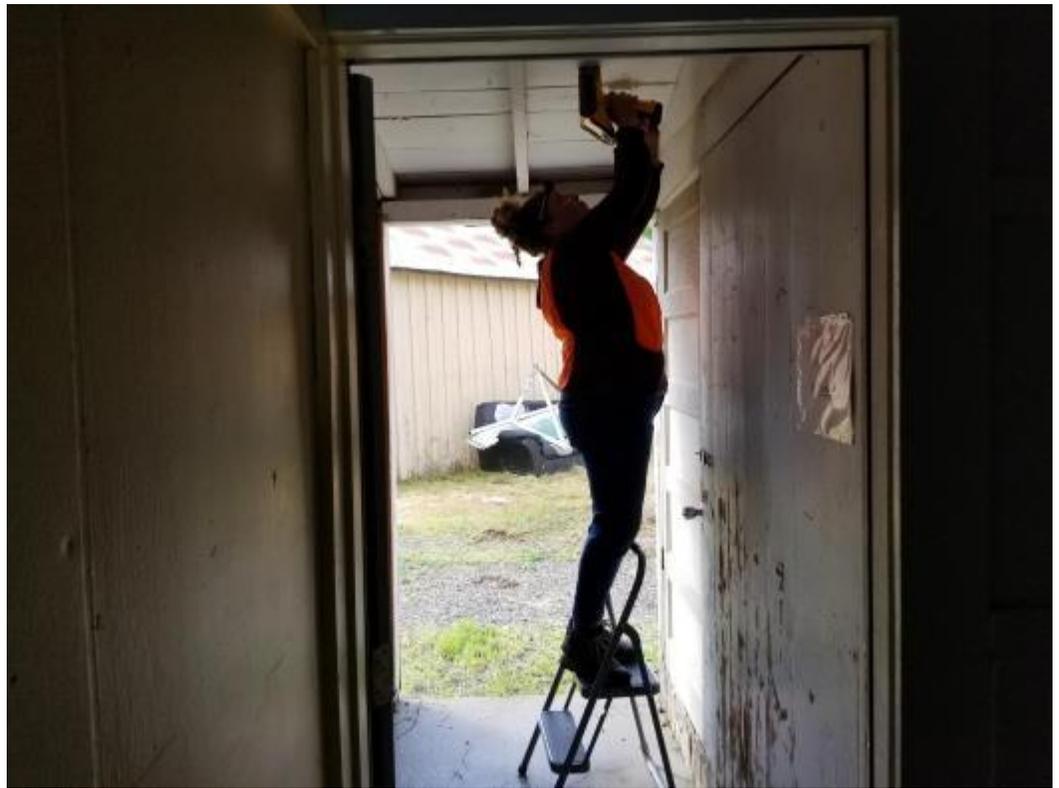
<b>Photo No.</b> <b>3</b>	<b>Date:</b> 06/20/2019
<b>Description:</b>  Sarah Ricard XRF screening the ceiling in Room D for LBP. This ceiling screened positive for lead.

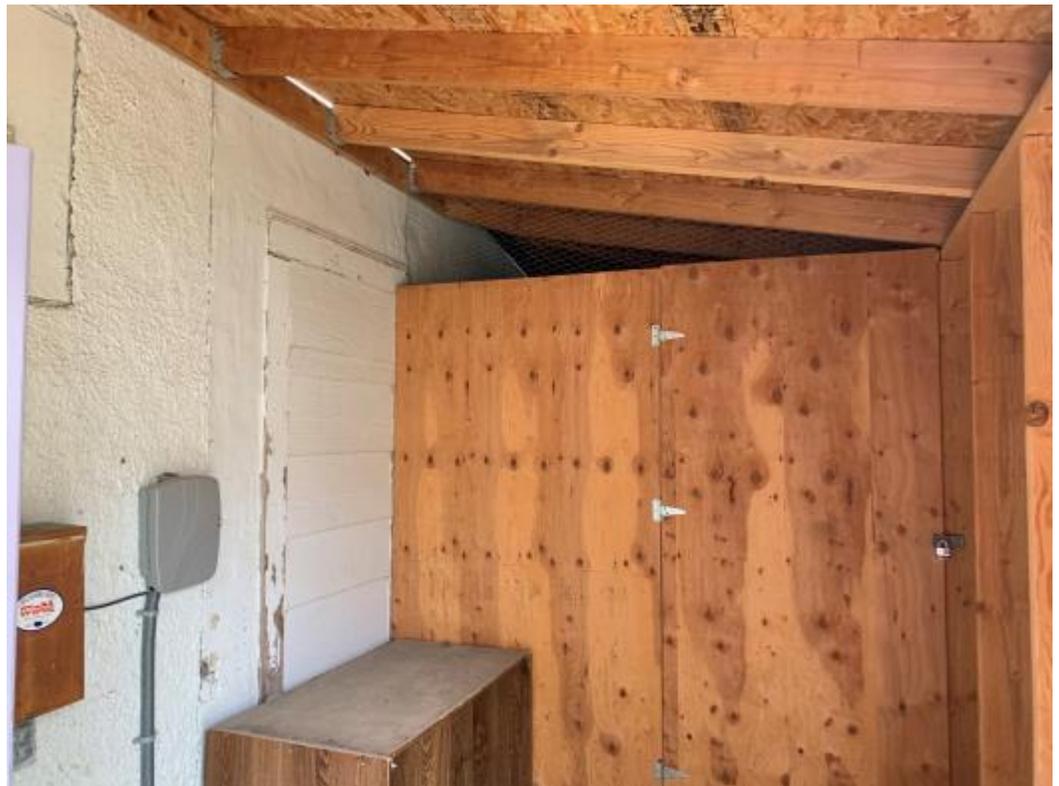
- No sink coatings were encountered.
- An exterior storage area (Storage), only accessible from the rear of the building, was padlocked and inaccessible to field personnel (**Photo 4, Attachment A**). The area is approximately 10 feet by 7.5 feet with a sloping roof at an average height of approximately 7 feet high (approximately 202.5 square feet [sq. ft.]) (**Figure 2**). The entrance wall and door are wood; therefore, are not suspect ACM. It is to be assumed that the building material inside the room is ACM if it is not wood, metal, or glass or until further sampling is completed.

- An exterior storage area (Storage), only accessible from the rear of the building, was padlocked and inaccessible to field personnel (**Photo 4, Attachment A**). The area is approximately 10 feet by 7.5 feet with a sloping roof at an average height of approximately 7 feet high (approximately 202.5 sq. ft.) (**Figure 3**). It is to be assumed that the building material inside the room contains LBP if it is painted or until further XRF screening or sampling is completed.

<b>Photo No.</b> <b>4</b>	<b>Date:</b> 06/20/2019
<b>Description:</b>  Inside Room D, and the entrance to the inaccessible storage area.

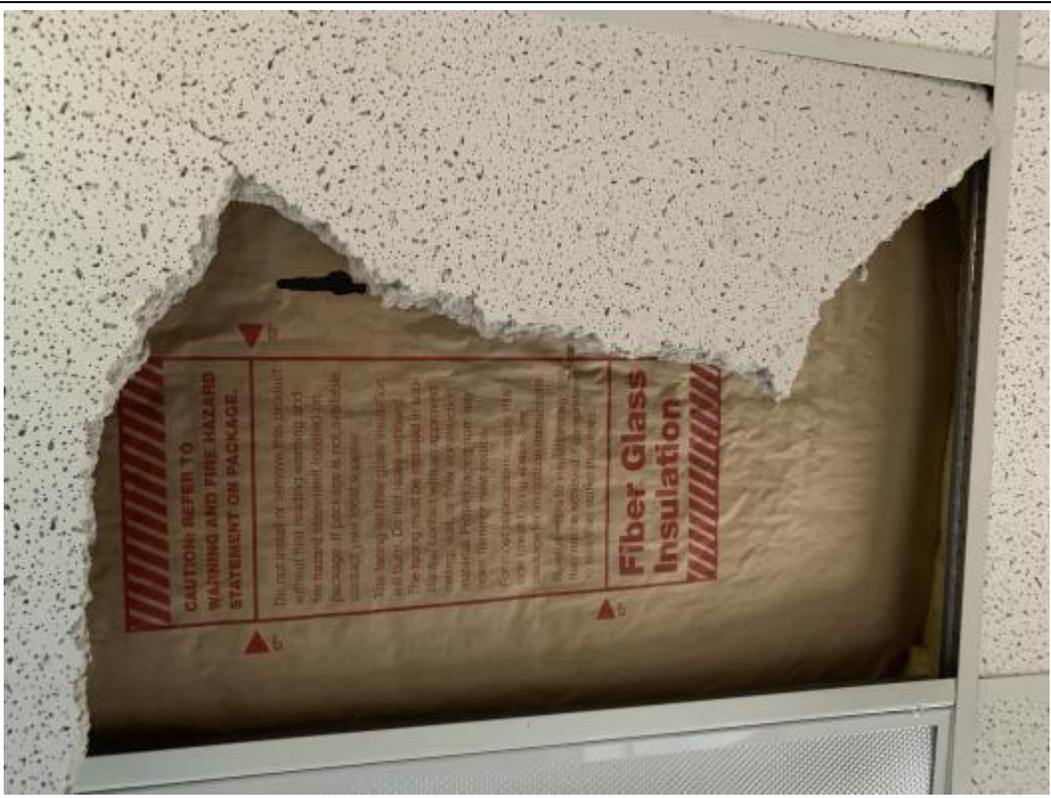
<b>Photo No.</b> <b>5</b>	<b>Date:</b> 06/20/2019
<b>Description:</b>  Fiberglass insulation used throughout the building.

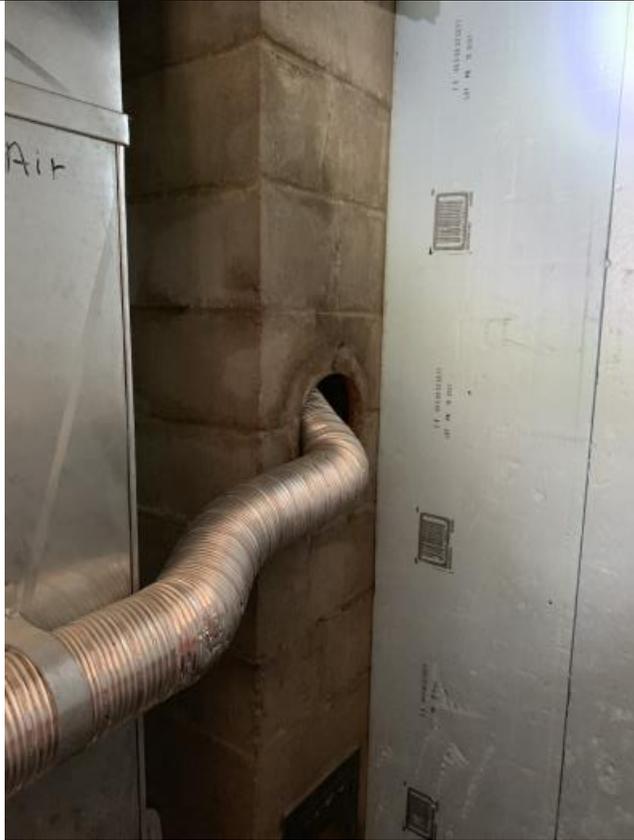
- No pipe insulation or boiler jackets were observed.
- A chimney was identified on the first floor, the brick and mortar were sampled for asbestos, the door to the chimney was opened and no other building material was identified inside.

<b>Photo No.</b> <b>6</b>	<b>Date:</b> 06/20/2019
<b>Description:</b>  The chimney identified on the first floor in Room E did not test positive for asbestos.

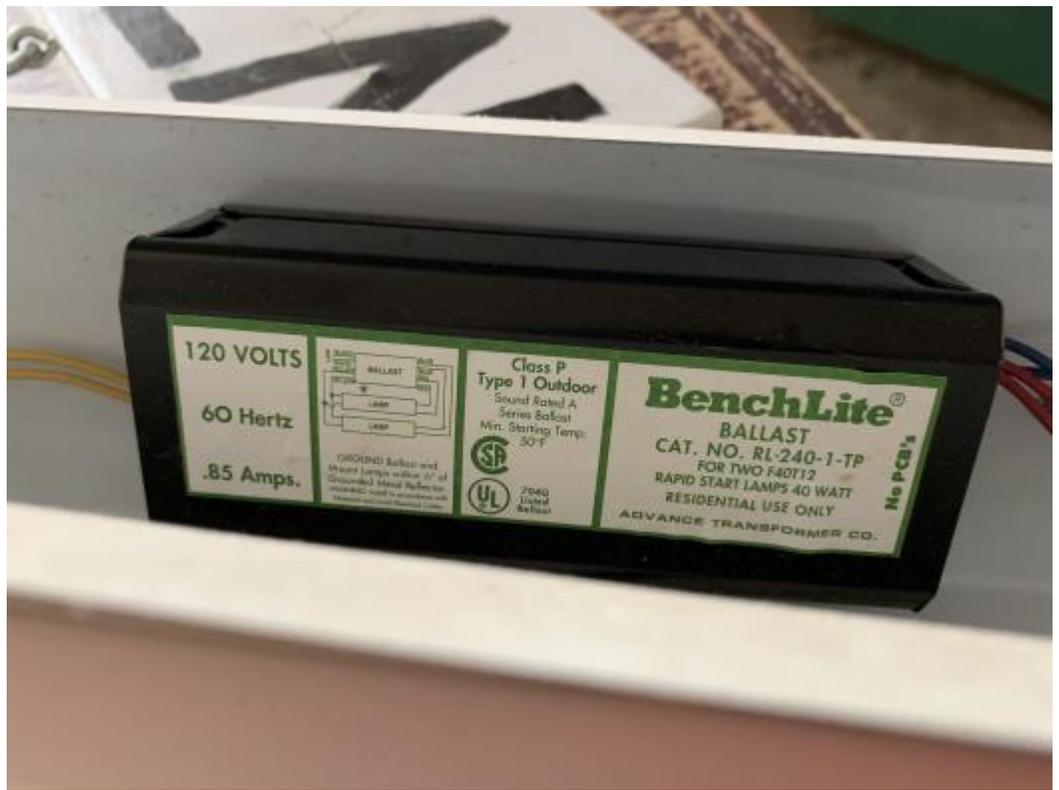
<b>Photo No.:</b> 7	<b>Date:</b> 06/20/2019
------------------------	----------------------------

A light ballast indicating no PCBs.

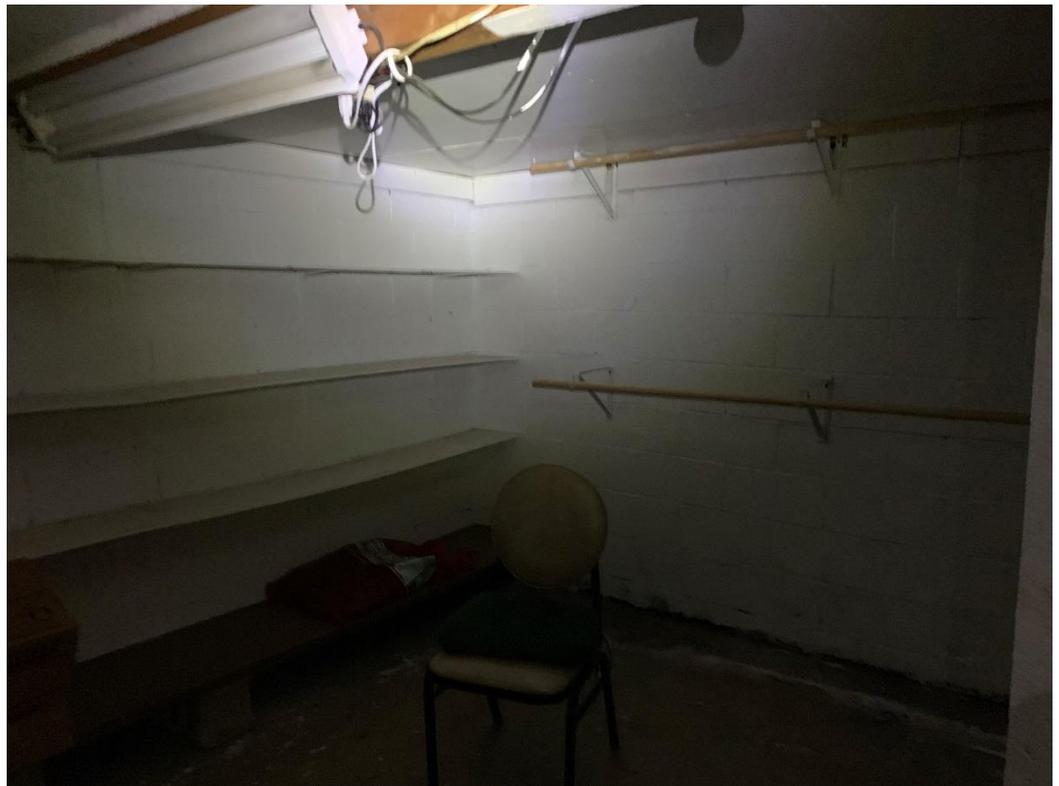
<b>Photo No.:</b> 8	<b>Date:</b> 06/20/2019
------------------------	----------------------------

View of basement. No ACM or LBP were identified in the basement.

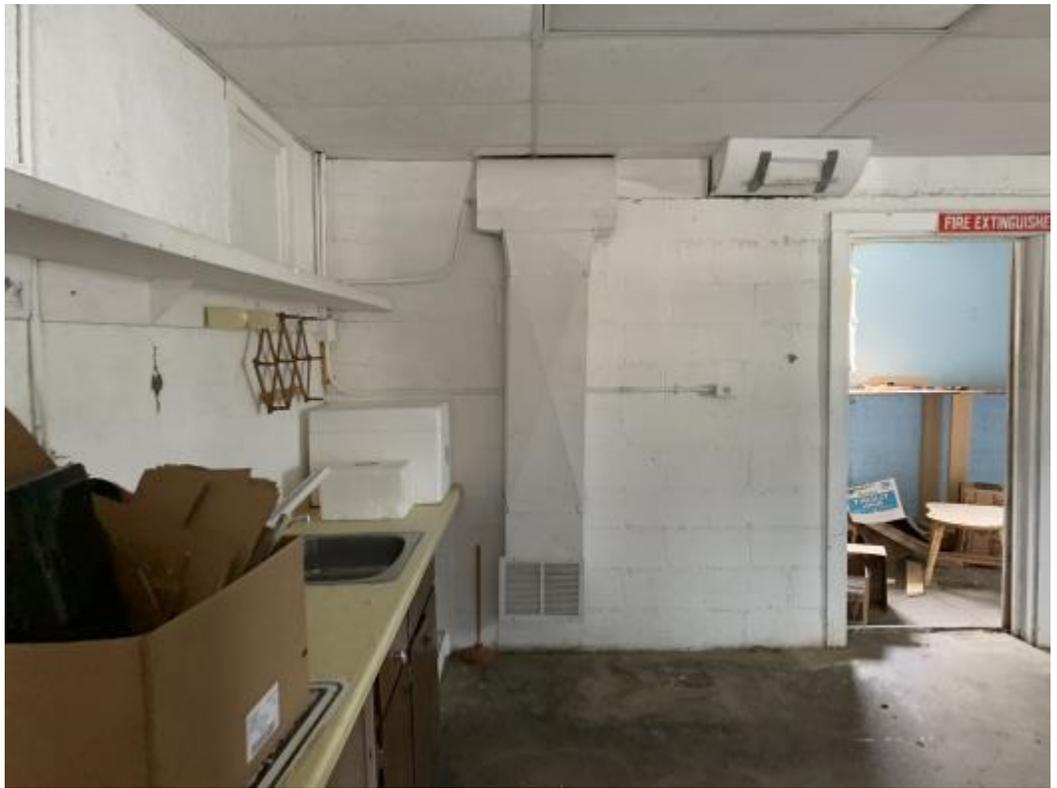
<b>Photo No.</b> <b>9</b>	<b>Date:</b> 06/20/2019
<b>Description:</b>  Room C interior walls and door frame identified to have LBP.

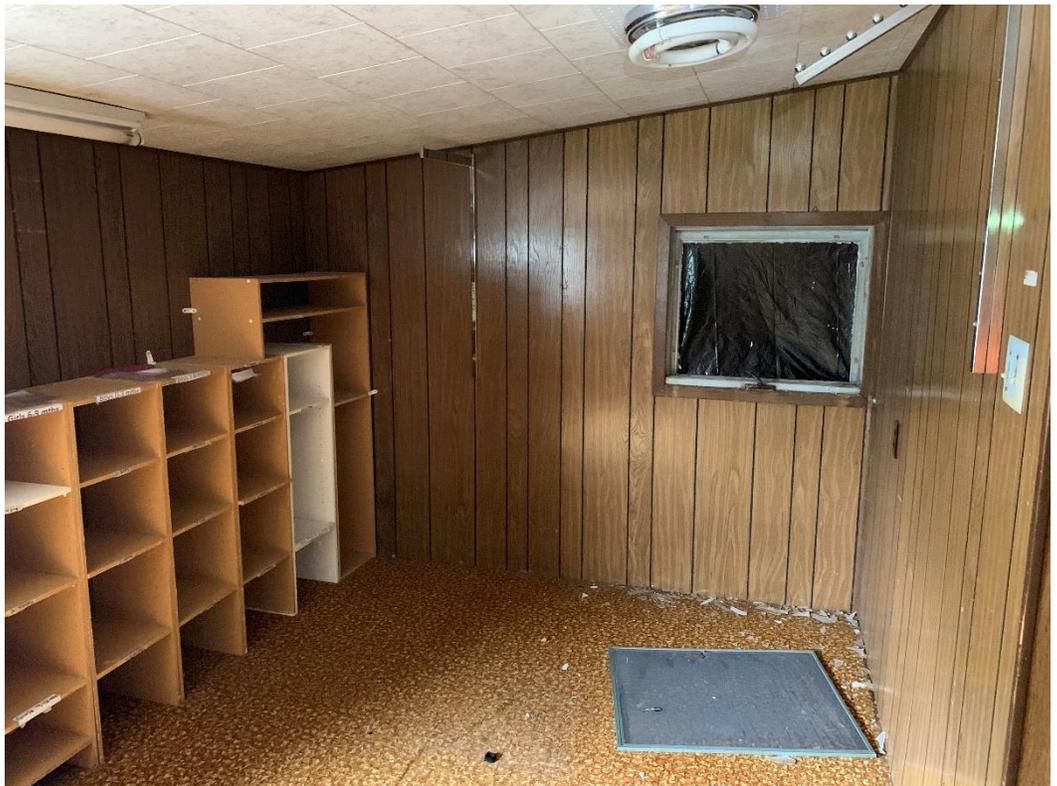
- One (1) potential PCB-containing fluorescent light fixture was observed on the second floor of the building (**Photo 10, Attachment A**).
- One (1) mercury-containing thermostat was observed on the first floor of the building (**Figure 3**).

<b>Photo No.</b> <b>10</b>	<b>Date:</b> 06/20/2019
<b>Description:</b>  View of second floor room. No LBP or ACM were identified on this floor. Potential PCB-containing light fixture shown in top right of photo.

- The potential PCB-containing light fixture should be properly removed and disposed of prior to demolition activities.
- The mercury ampule should be removed and properly disposed of prior to demolition activities.

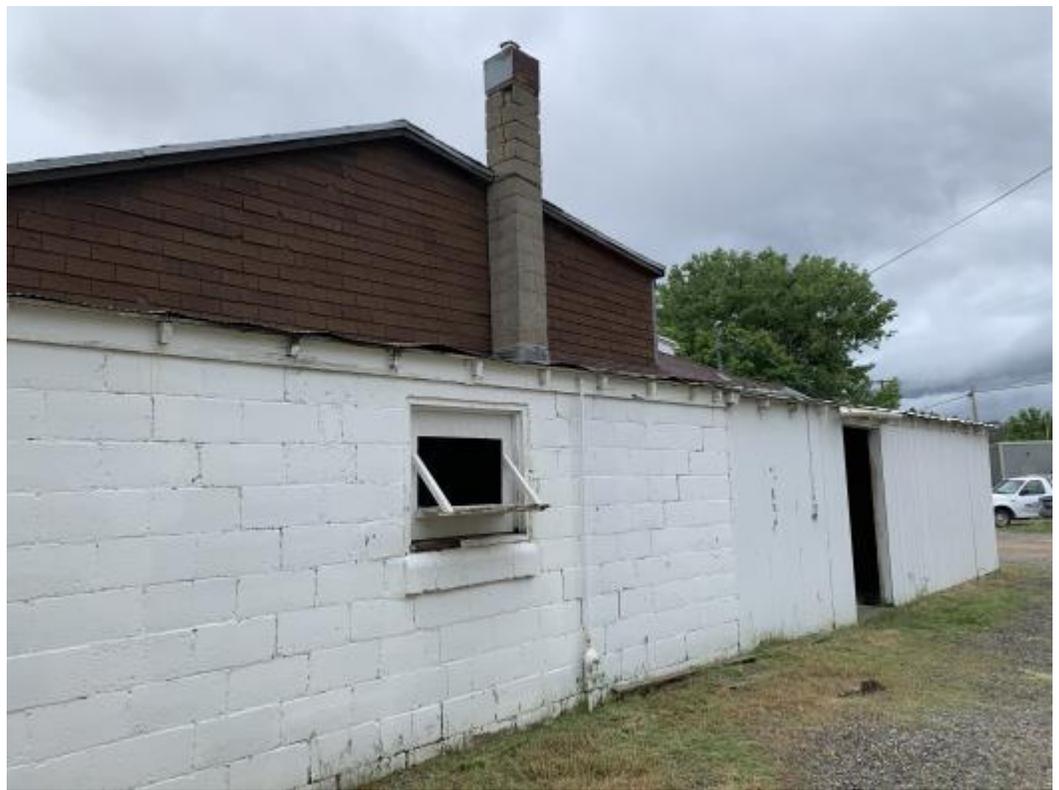
<b>Photo No.</b> <b>11</b>	<b>Date:</b> 06/20/2019
<b>Description:</b>  View of rear exterior window trim that screened positive for LBP.

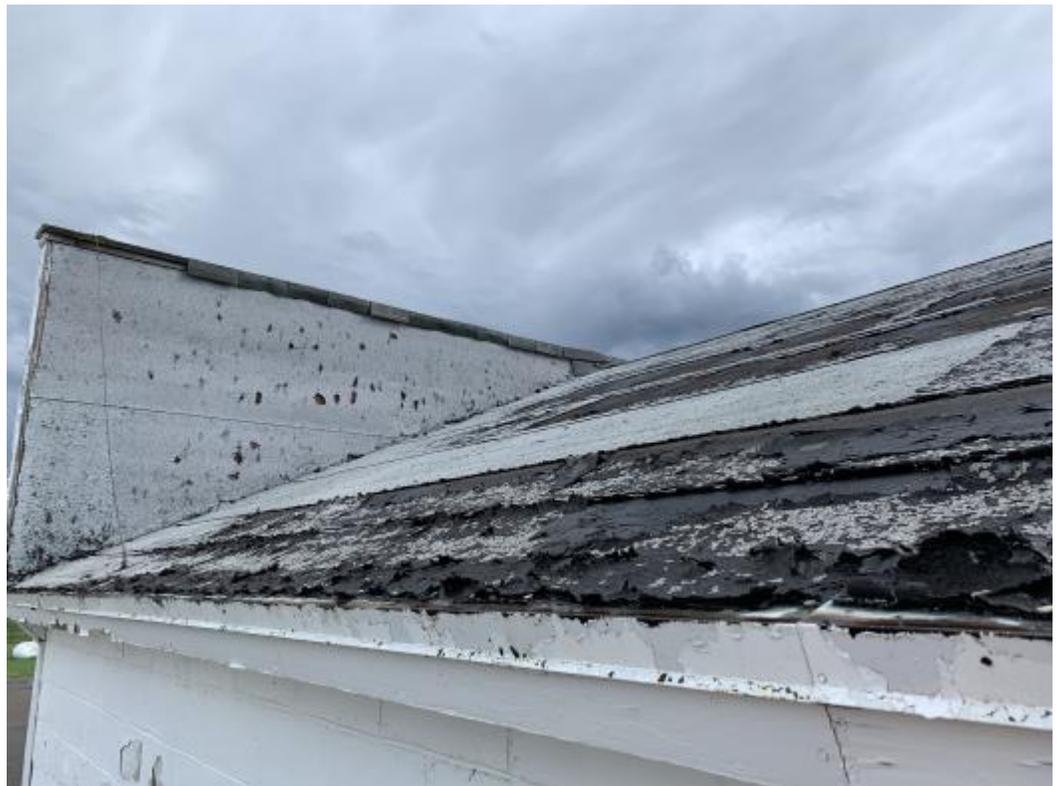
<b>Photo No.</b> <b>12</b>	<b>Date:</b> 06/20/2019
<b>Description:</b>  Roofing material that tested positive for asbestos. This section of the roof had a total of six layers.
