July 23, 2019

**SUBJECT: Hazardous Substance Assessment Report
Harlowton Railyard
Harlowton, Wheatland County, Montana
Tetra Tech Project No. 117-8292004.100**

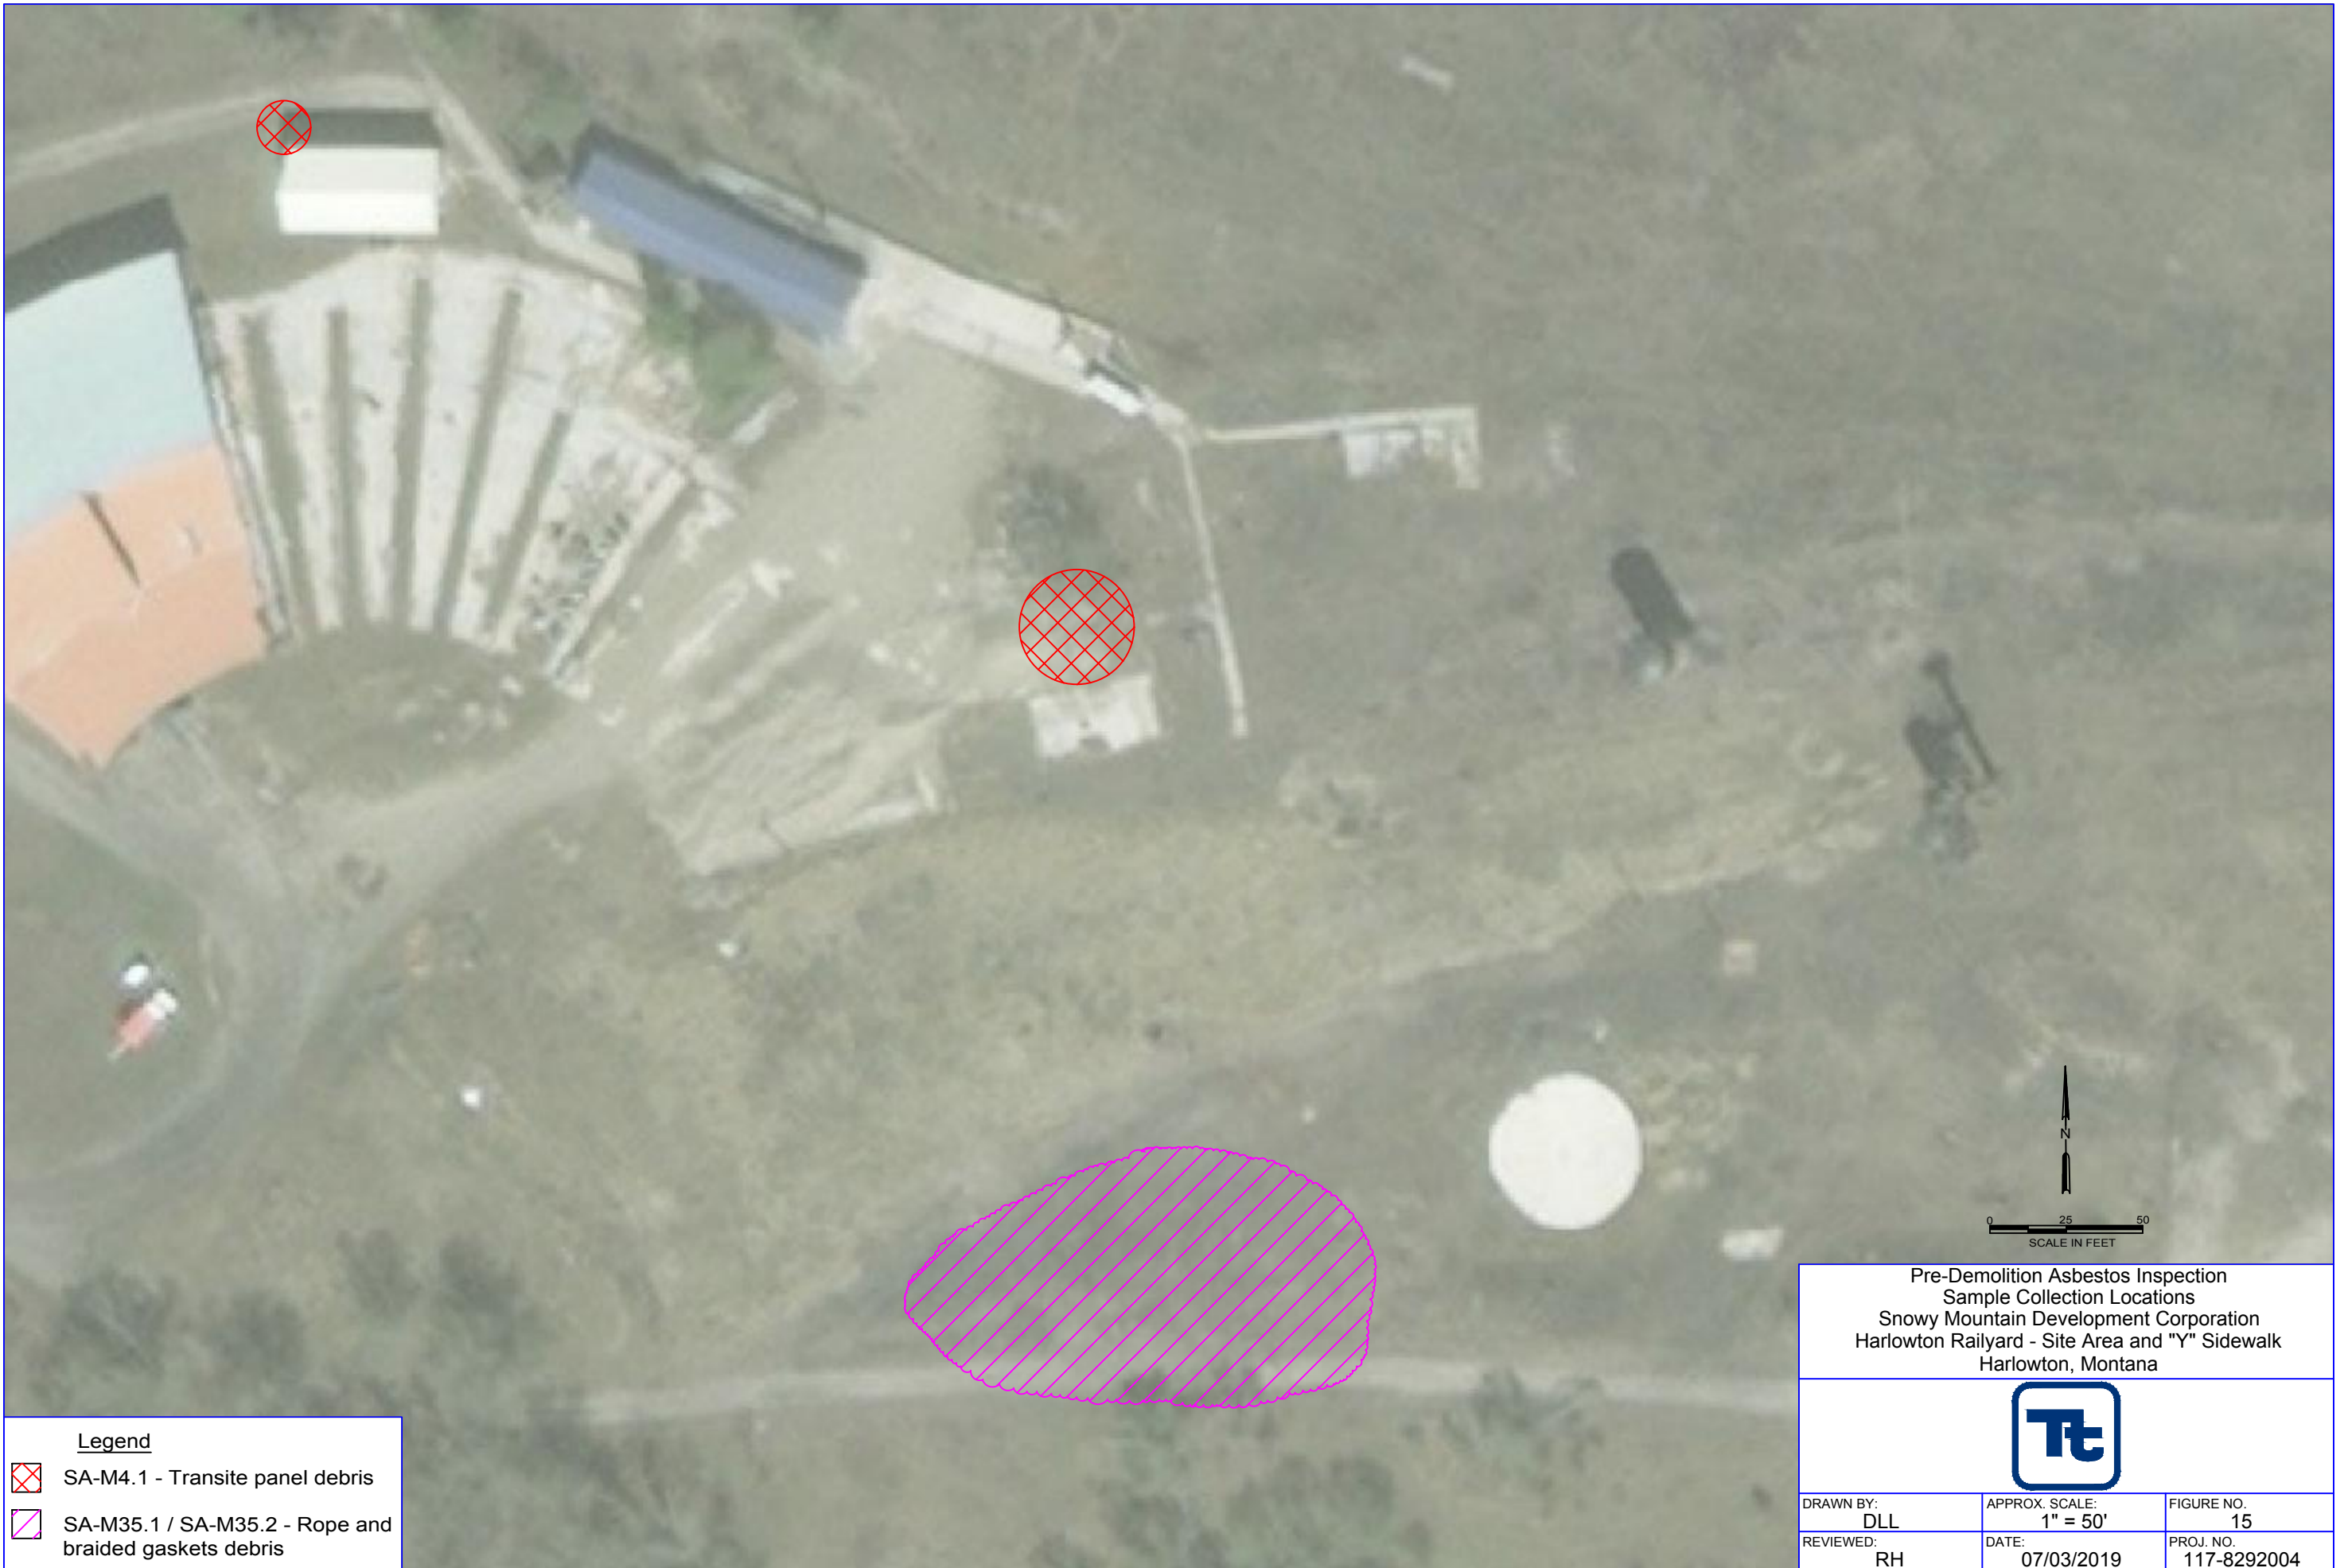
Pre-Demolition Asbestos Inspection
Sample Collection Locations
Snowy Mountain Development Corporation
Harlowton Railyard - Site Area and "Y" Sidewalk
Harlowton, Montana

SA-M35.1 / SA-M35.2 - Rope and braided gaskets debris
