**PHASE II ENVIRONMENTAL SITE ASSESSMENT
FOR
CROWLEY BUILDING
311 WEST MAIN STREET
LEWISTOWN, FERGUS COUNTY, MONTANA**

Date Prepared	September 2017
TDD No.	0003/1705-13
Document Control No.	W0487.1A.01404
Contract No.	EP-S8-13-01
U.S. EPA Work Assignment Manager	Greg Davis

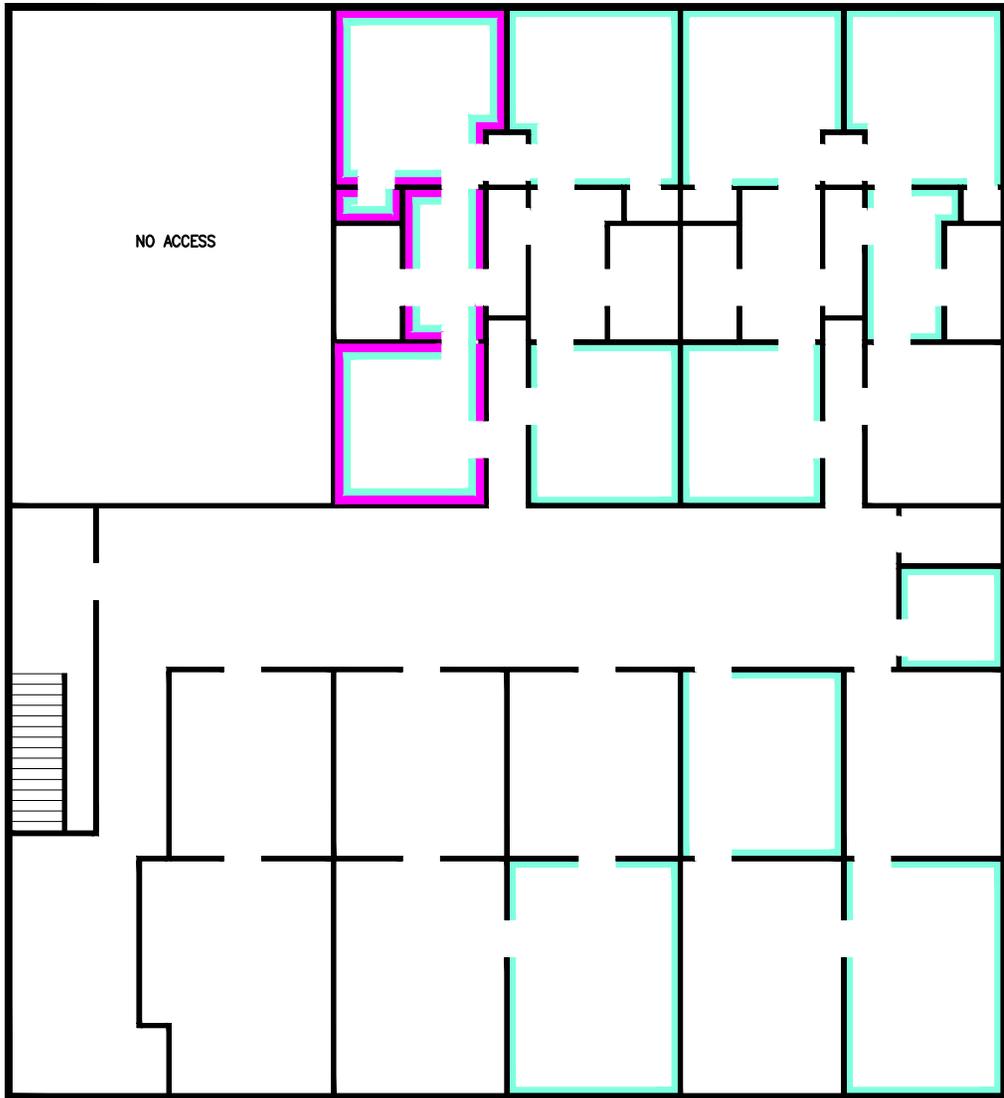
Figure
9

**LBP LOCATION AND EXTENT MAP
CROWLEY BUILDING – SECOND FLOOR
LEWISTOWN, FERGUS COUNTY, MONTANA
HAZARDOUS BUILDING MATERIALS SURVEY**

- LBP LEAD BASED PAINT
- LBP 10" BASEBOARD AND TRIM
- LBP HALF (4') WALL EXTENT

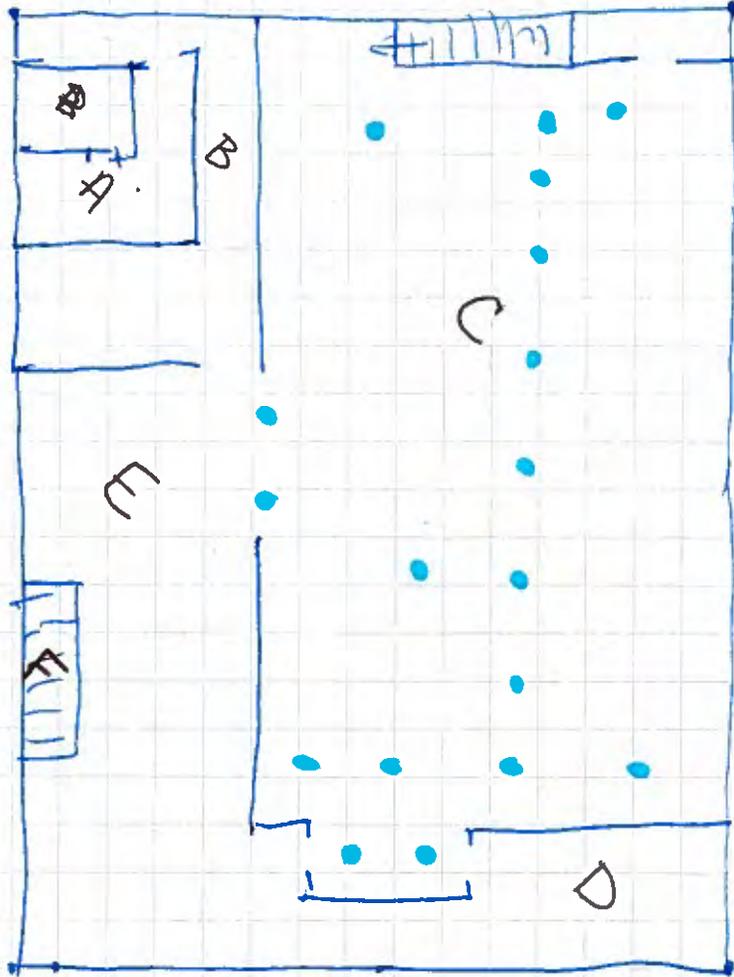
• 8" - 8" posts positive for LBP

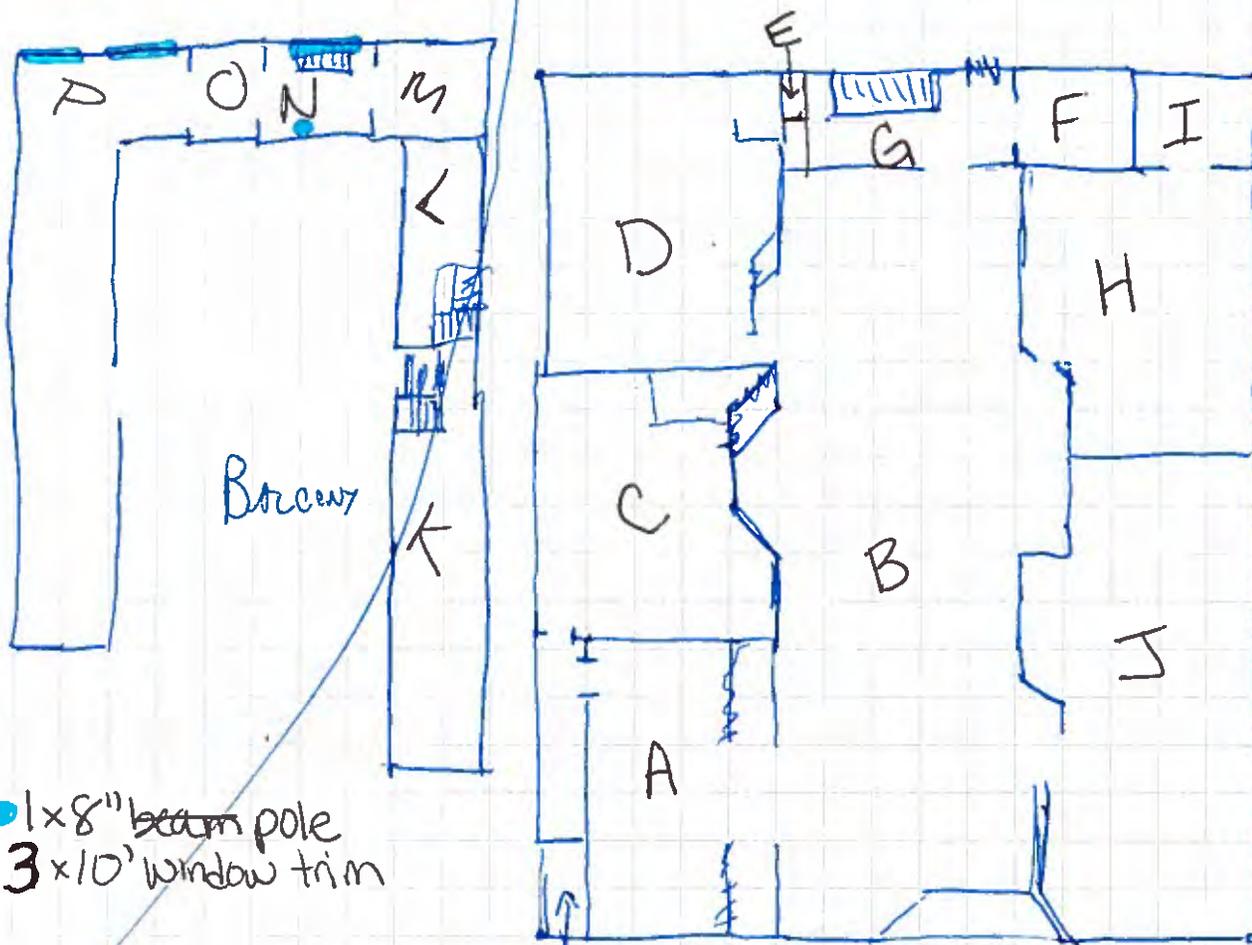
● 1x8" beam pole
3x10' window trim

Tin ceiling LBP positive - all of 1st floor ceiling

* 1 window accessible for window glaze check - NO GLAZE observed.
All other windows boarded up

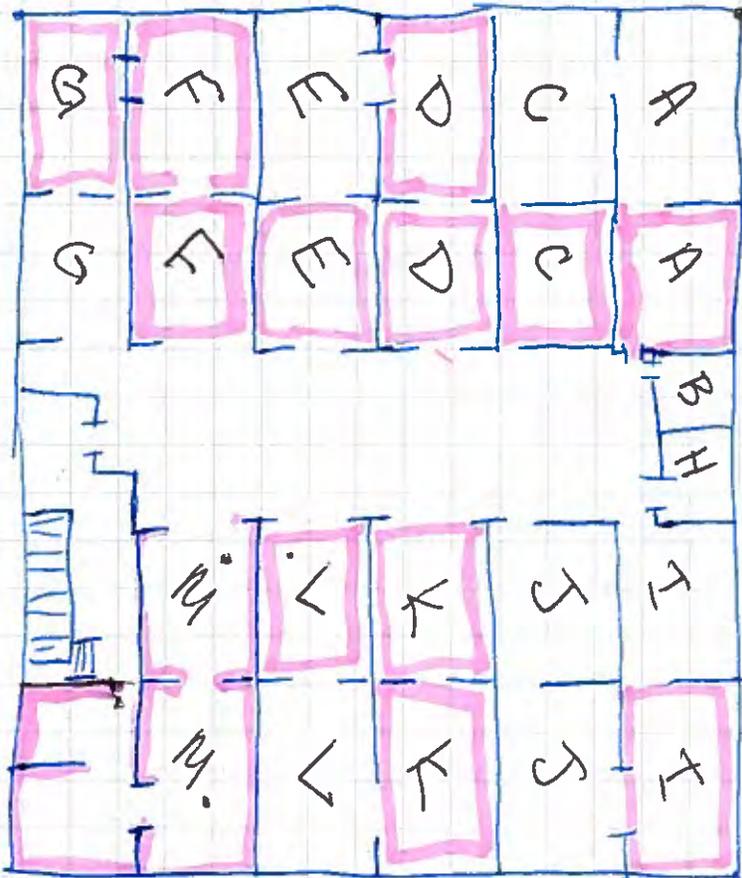
Brown wall in G (Full wall)

Pink wall in K (Full wall)

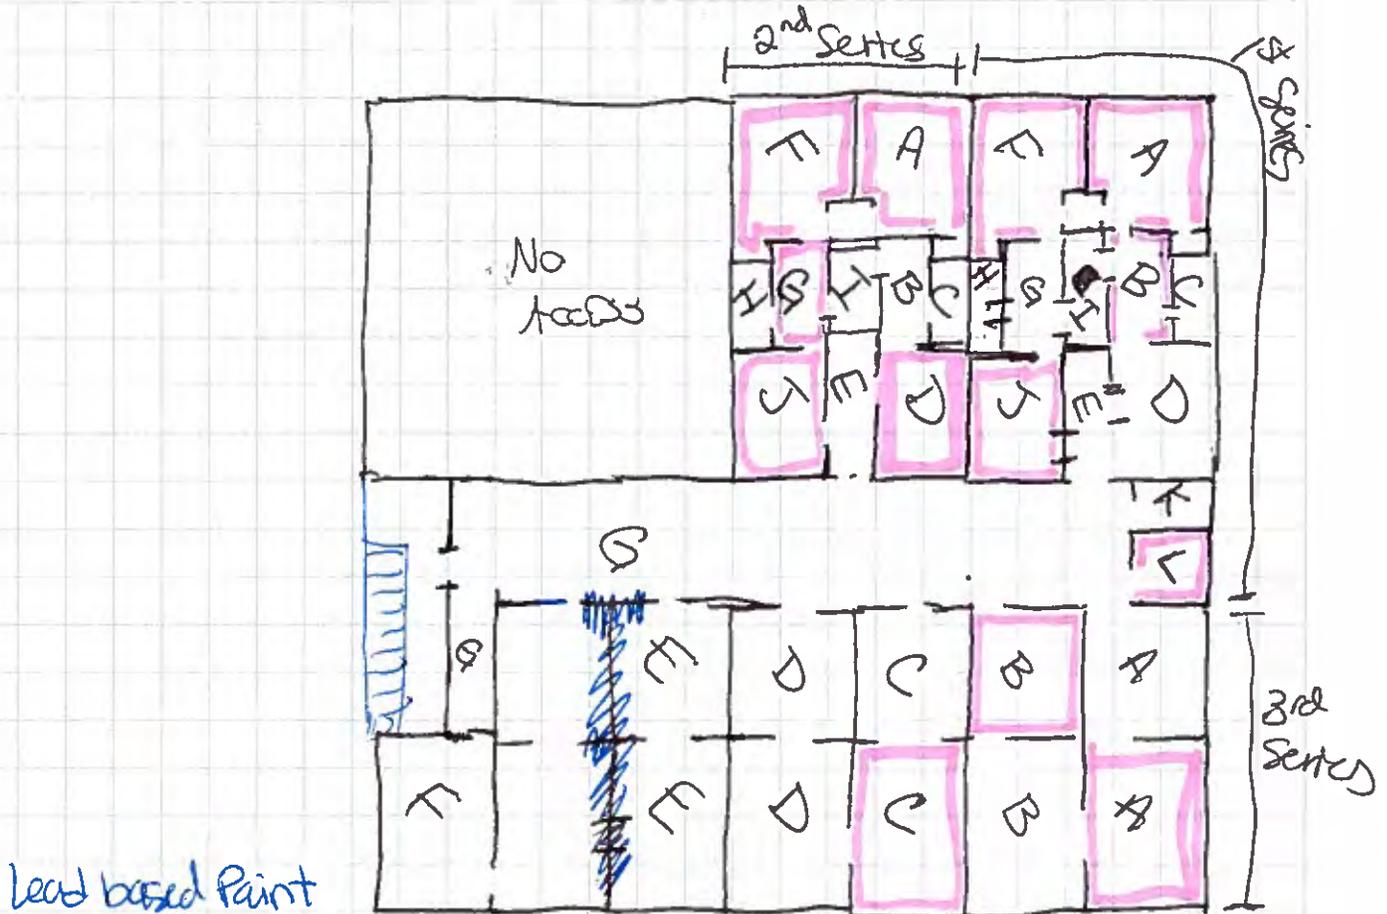
- 1st Series Apartments**

- (10.4ft high) Green walls in A, B, J
 - (10.4ft high) Pink walls in F
 - yellow walls in G, L
- 2nd Series Apartments**
